Dual Pin Lift Gate Receptacle VN

SP 379-001, Dual Pin Lift Gate Receptacle

(October 2014)

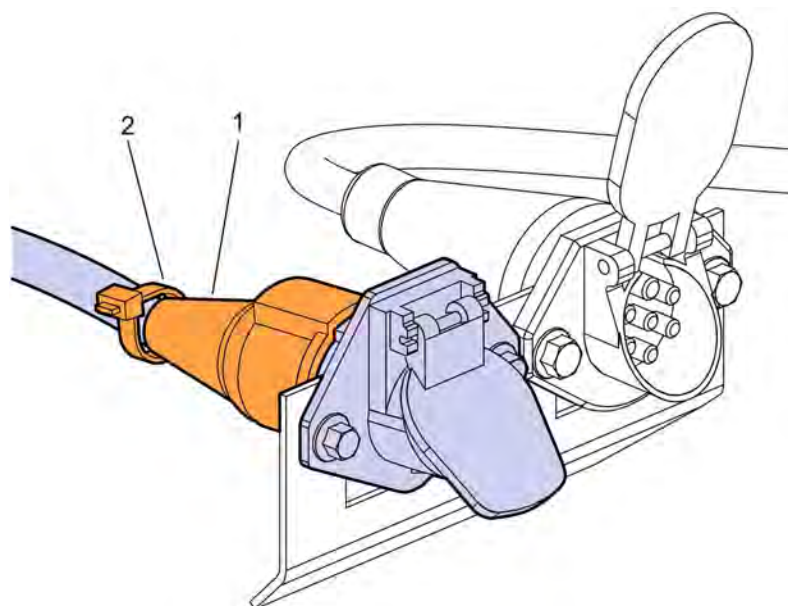
W3092534

Certain VOLVO trucks built between 07/05/2010 and 06/30/2014, equipped with a lift gate receptacle option can experience intermittent or erratic operation of lift gate equipment. Normal exposure to the elements caused corrosion build up at the dual pin lift gate receptacle. To ensure proper operation of all lift gate equipment, the terminals and studs of the dual pin lift gate receptacle will require cleaning along with an application of a corrosion inhibitor. Additionally, a boot and cable tie will be installed at the lift gate receptacle to protect the terminals from corrosion build up.

Dual Pin Lift Gate Receptacle Parts			
Item	Description	Part Number	Qty
1	Boot	25498777	1
2	Cable Tie	980464	1
3	Corrosion Inhibitor	21735988	1
