SB-10057198-2938

Title: Big Bore Intake Air Temperature/CACOT Sensor Damaged

Applies To: Prostar 113 Equipped with 2010 Emissions MaxxFORCE 11/13L and N13 Engines

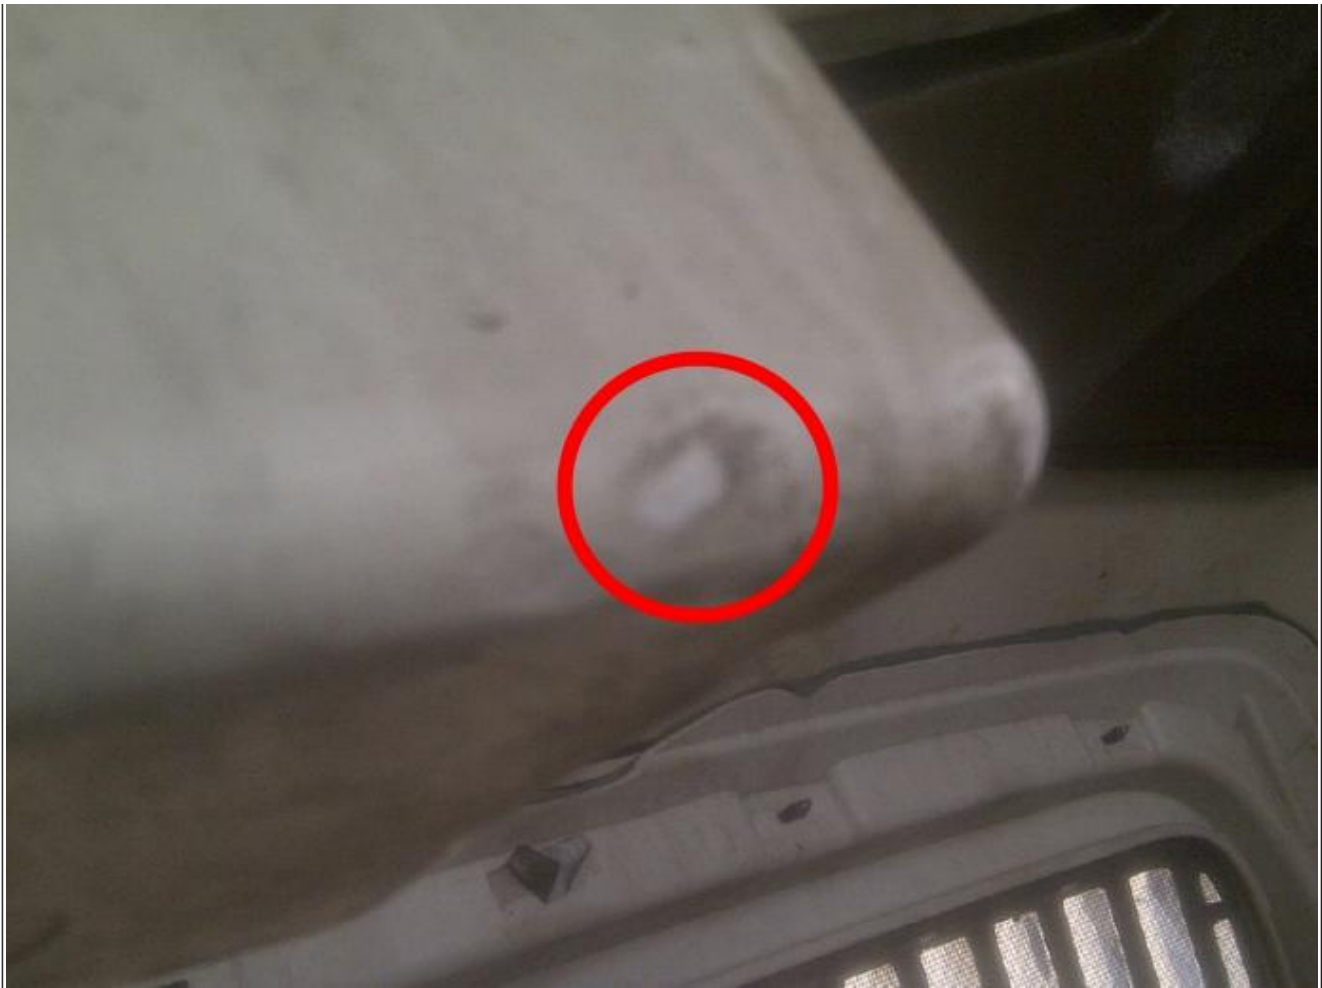
| Step | Action | Decision |
|---|---|--|
| 2 | <p>Verify hood to sensor contact.</p> <ul style="list-style-type: none"> • Inspect the inside of the hood for markings from rubbing the CACOT sensor. See figure #2 below for an example of hood rubbing marks. • Are there witness marks on the hood? | <p>1. Yes. Proceed to hood modification procedure, below.</p> |

Figure 2: Rub mark in the hood from CACOT sensor contact (air inlet cowl).
