# Technical Service Bulletin

## 94 Headlight internal diagnosis before replacement, various concerns

94 14 57 2038908/1 November 5, 2014.

Model(s)	Year	VIN Range	Vehicle-Specific Equipment
A8	2014 - 2016	All	Not Applicable

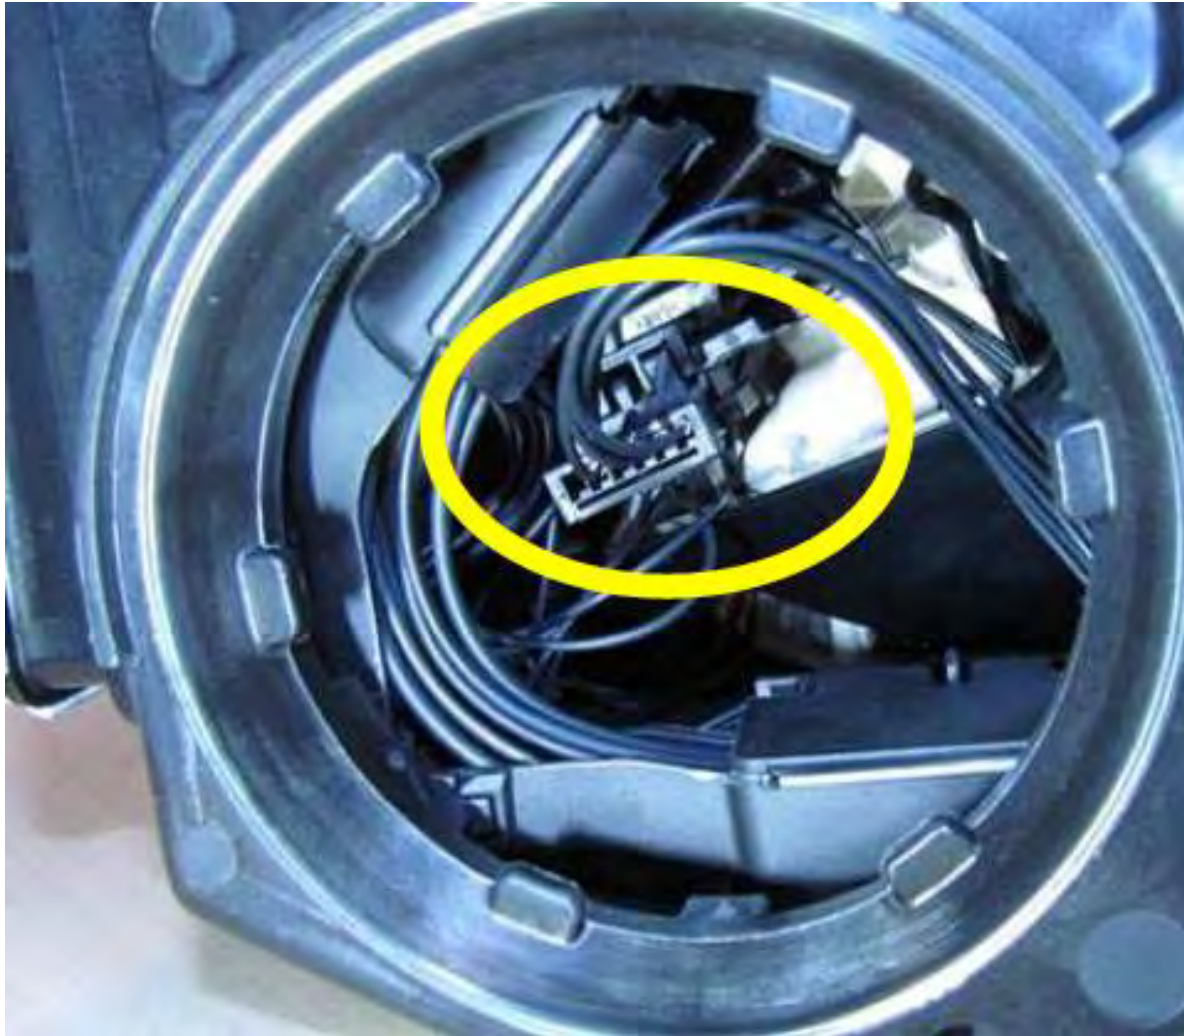
**For symptom A (One or more LEDs in the low beam are inoperative on one side):**

**Figure 1.** Check this connector.

Check the connector shown below (Figure 1).

3. If any connectors are not correctly plugged in, check connector for damage. If no damage is found, reconnect the connector. Do not use a screwdriver or other metal object. If all connectors were plugged in correctly, this bulletin does not apply.
4. Reconnect the headlight to the vehicle, then check the headlight operation. It is not necessary to fully install the headlight to test the headlight operation.
5. If headlight operation is fully restored, fit and adjust the headlight. Additional adaptations (radar sensor, Topview camera, night vision) may be necessary, depending on vehicle equipment.

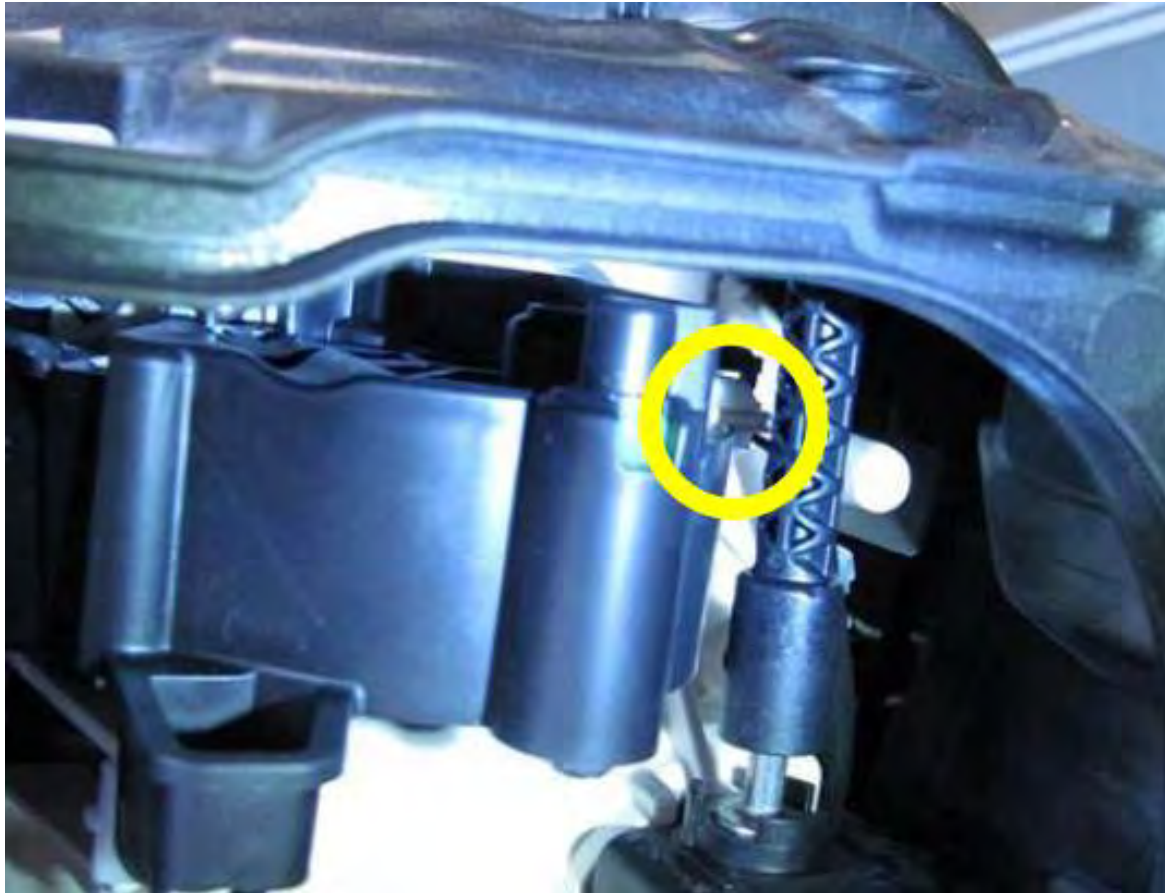
**For symptom B (Internal cooling fan inoperative in one headlight):**

*Figure 2. Check this connector.*

Check the connector shown below (Figure 2).

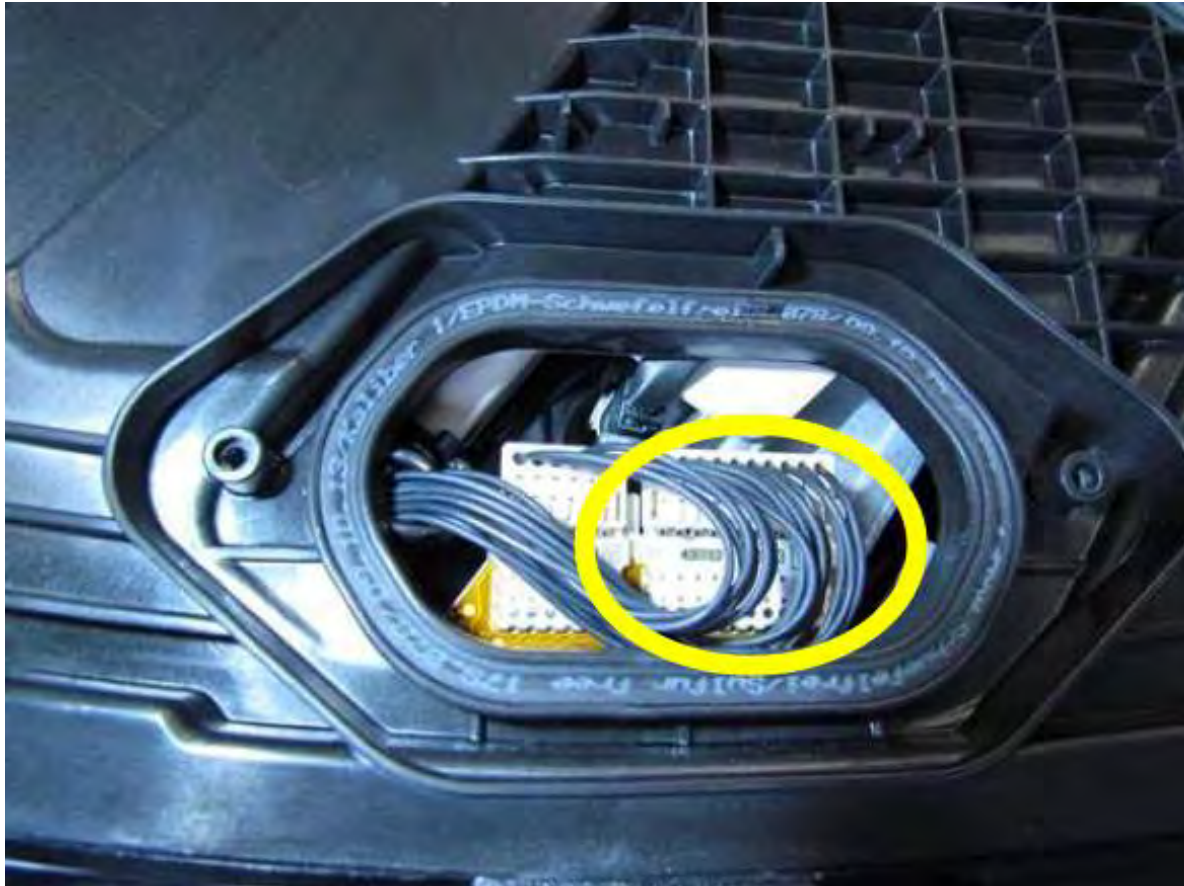
**For symptom C (DRL inoperative on one side):**

**Figure 3.** Check this connector.

Check the connector shown below (Figure 3).

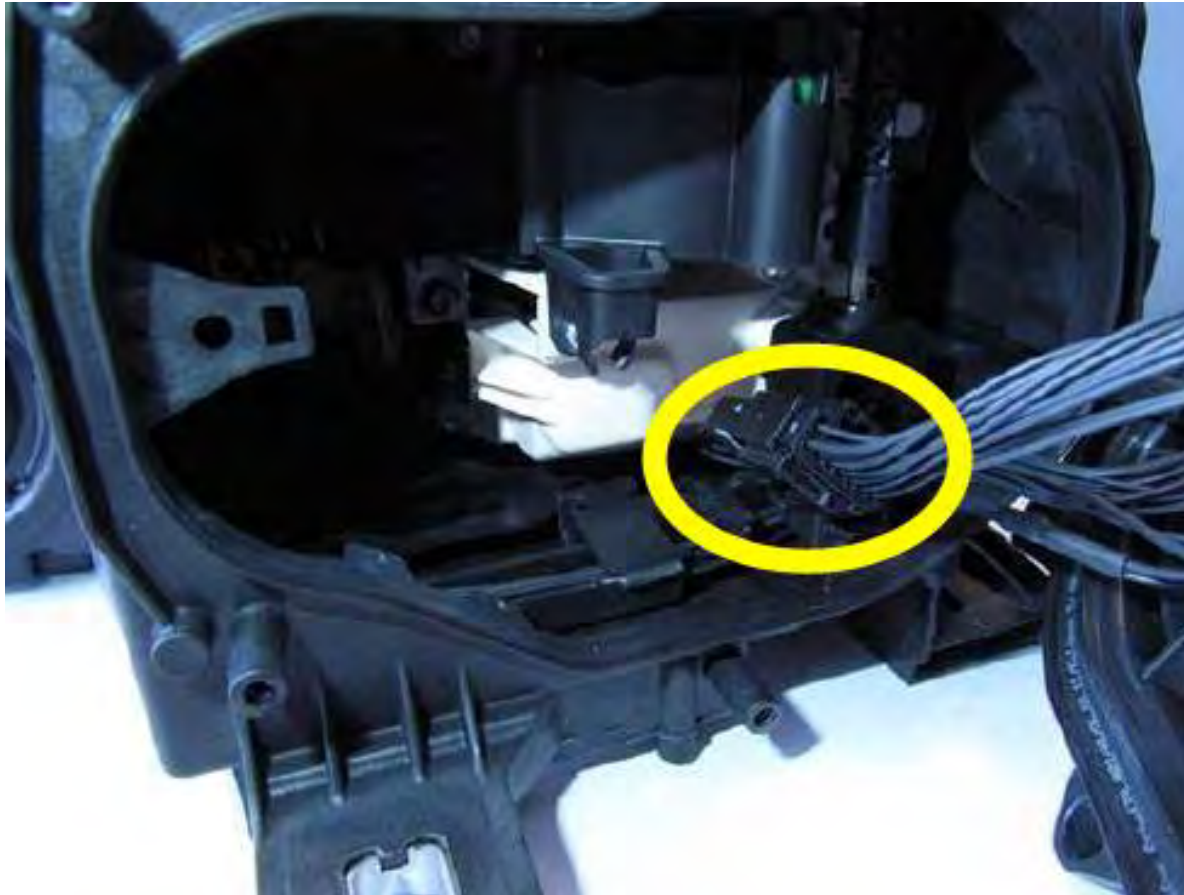
**For symptom D (One or more LEDs in the high beam are inoperative on one side):**

*Figure 4. Check this connector.*

Check the connectors shown below (Figure 4 and Figure 5).

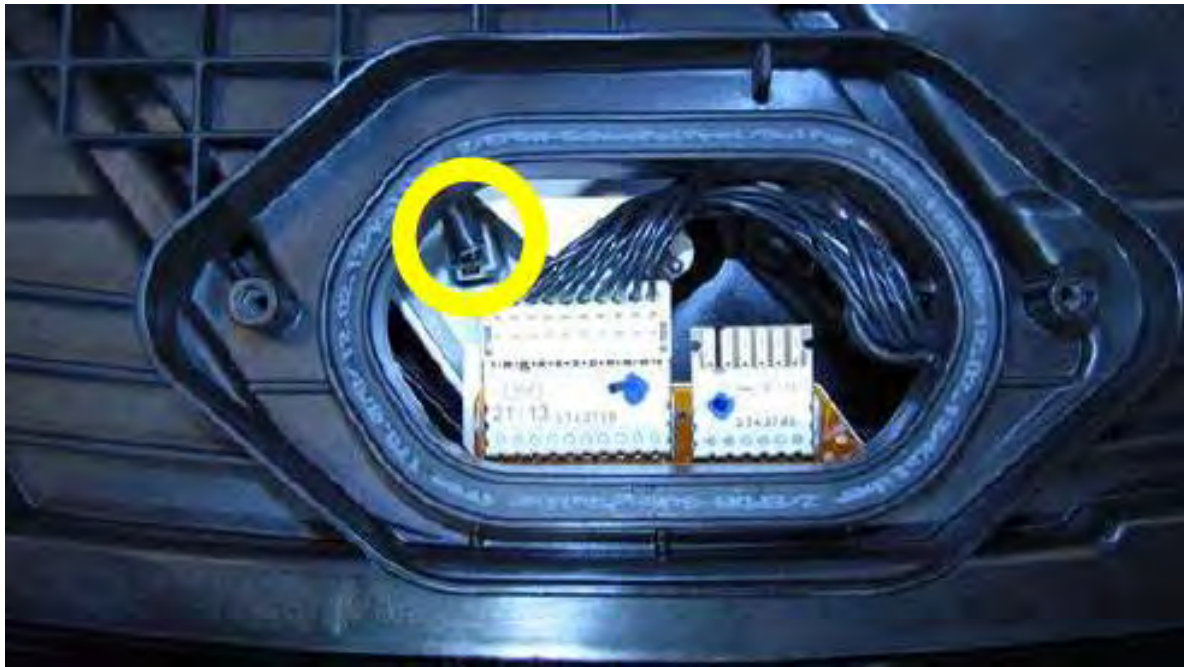
**Figure 5.** Check this connector.

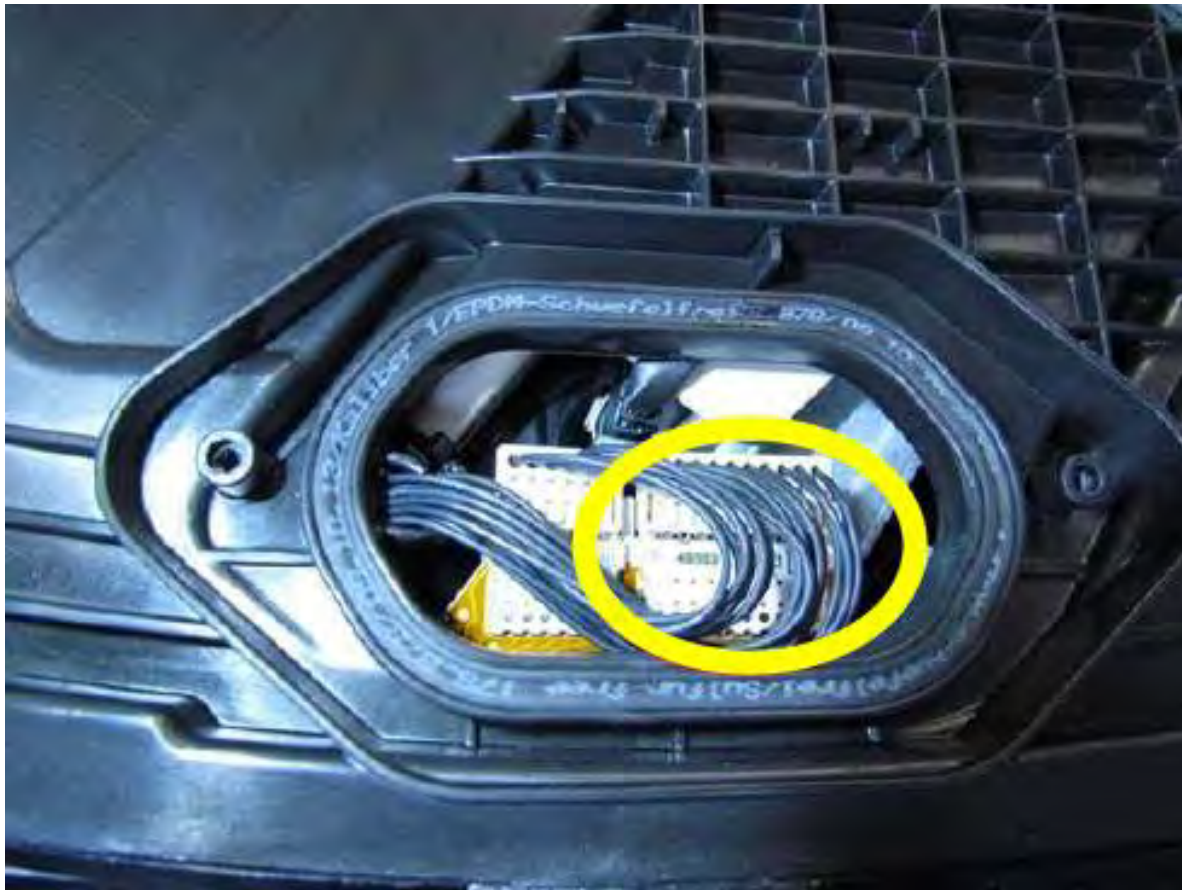
**For symptom E (LED turn signal inoperative in one headlight):**

**Figure 6.** Check this connector.

Check the connector shown below (Figure 6).
