Tech Tips

TT 91-14-05

Date: November 7, 2014

2011-2013 Routan Turn Signals Will Not Activate after TIPM Replacement

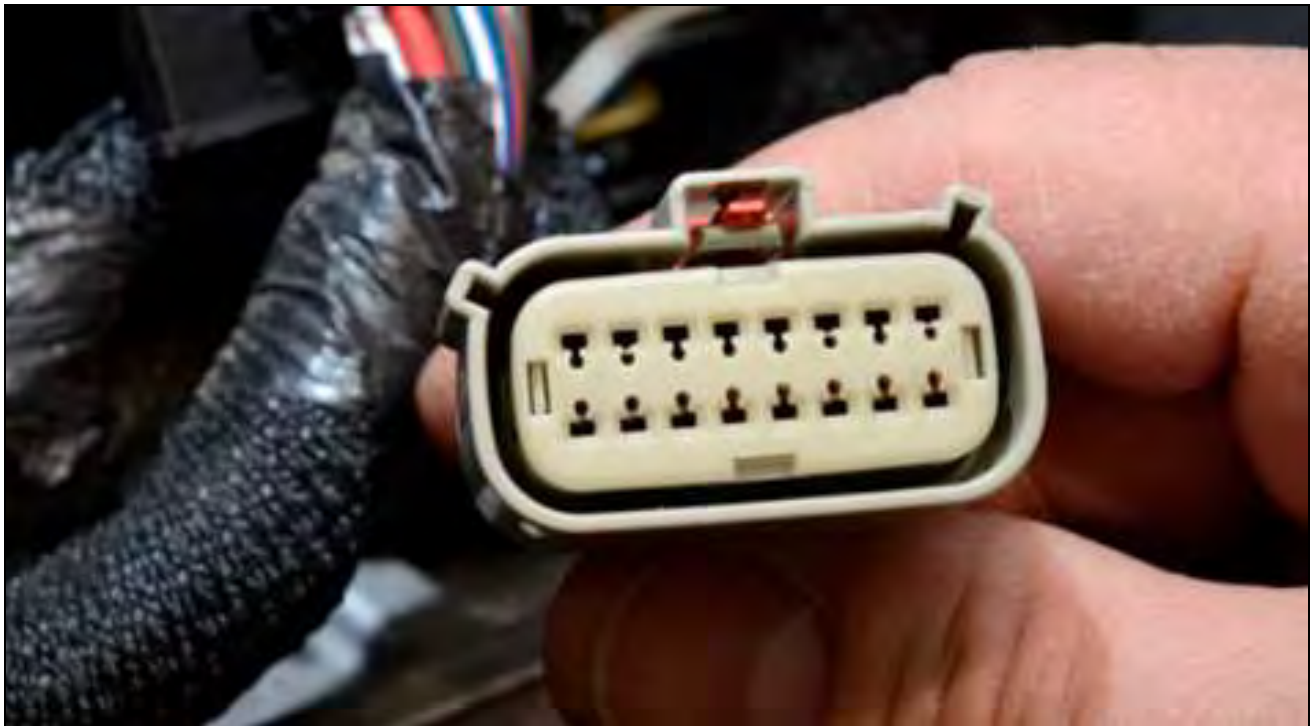
Figure 1

2. With the TIPM removed from the vehicle locate Gray 16 way the TIPM C4 connector on the vehicles wiring harness (Figure 1).

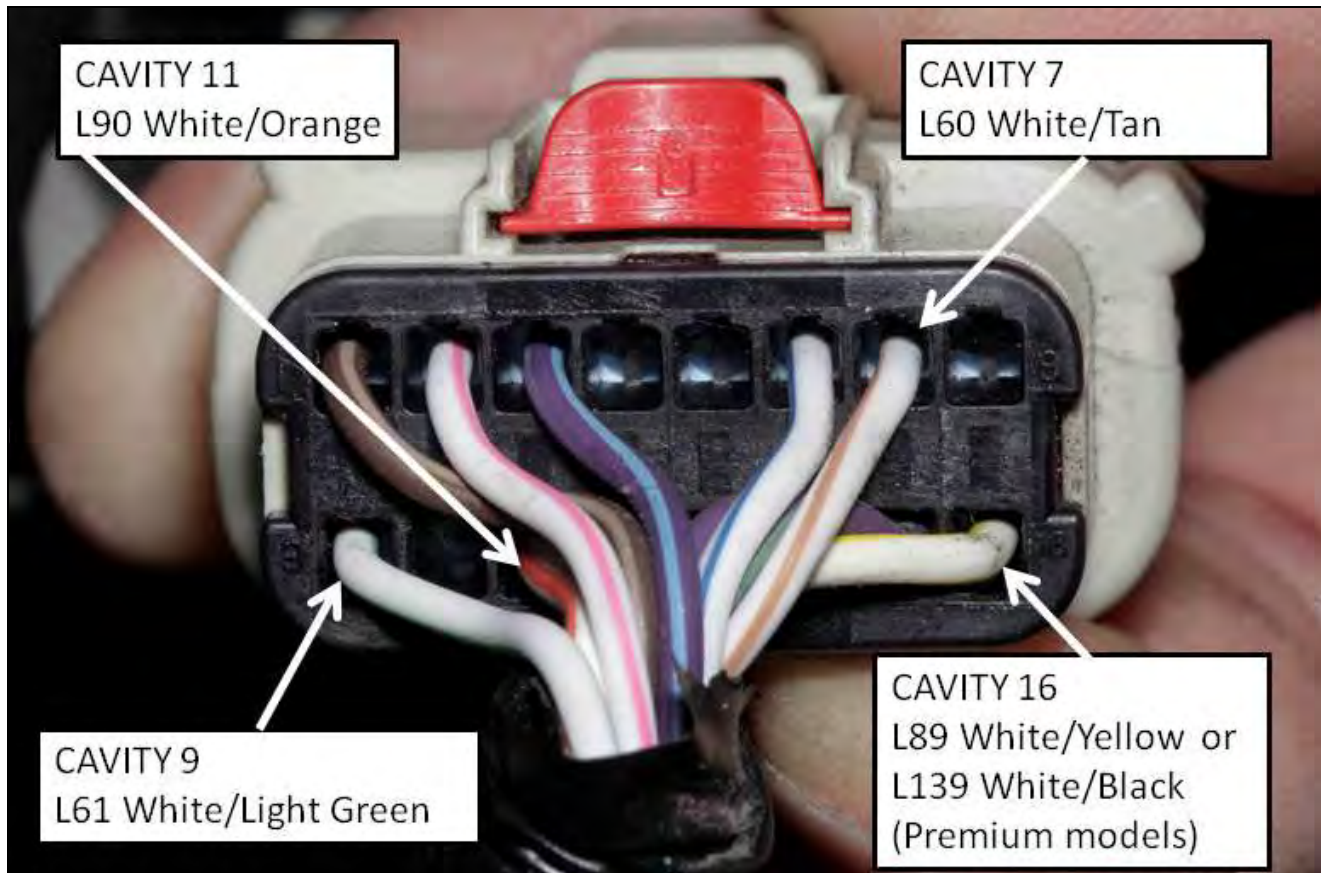
Figure 2

3. Identify cavity 7 of the C4 connector. If the wire in cavity 7 is White with Tan proceed to the next step (Figure 2).
4. Identify cavity 9 of the C4 connector. If the wire in cavity 9 is White with Light Green proceed to the next step.
5. Identify cavity 11 of the C4 connector. If the wire in cavity 11 is White with Orange or there is no wire present continue to the next step.
6. Identify cavity 16 of the C4 connector. If the wire in cavity 16 is White with Yellow or White with Black or there is no wire present proceed to the next step.
