Freightliner
Service Bulletin

32-50

Incorrect ECAS Ride Height Sensor and Linkage Installation

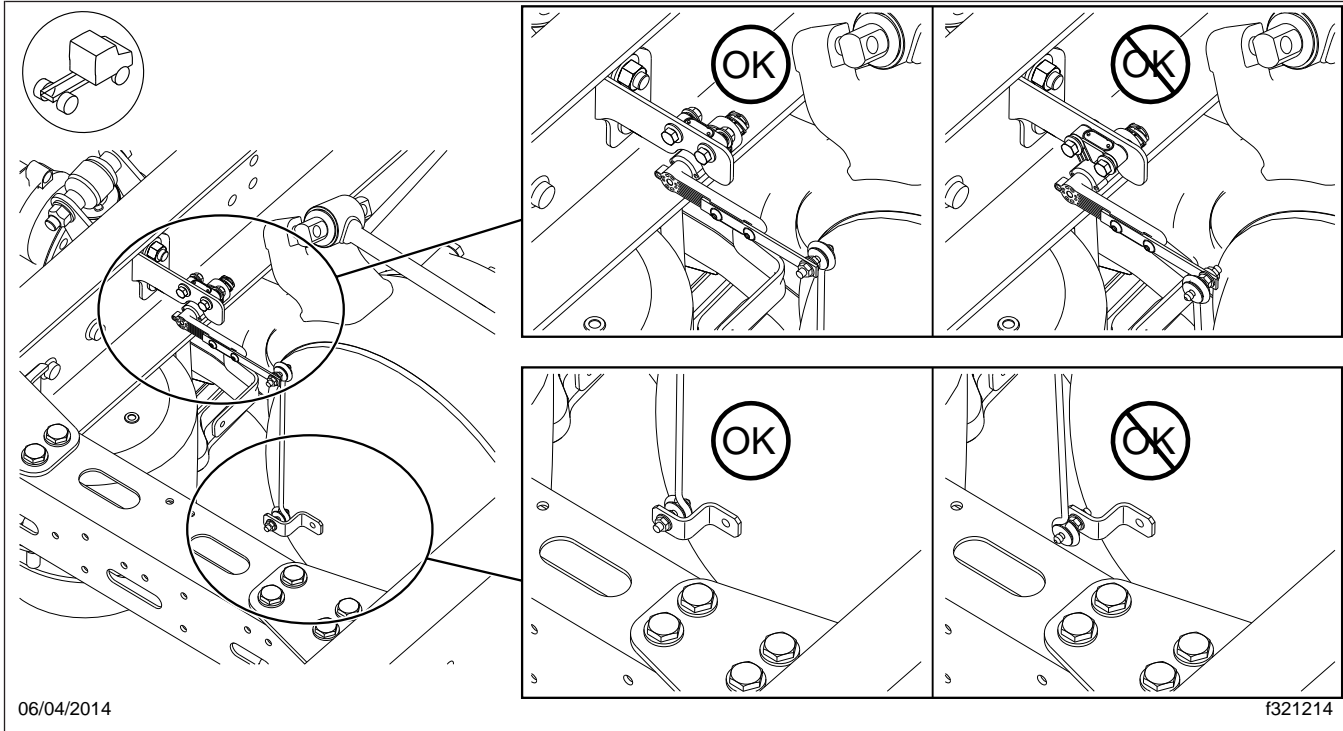
Fig. 1, Inspection of the Ride Height Sensor Installation

Ride height sensor arms have broken on some vehicles equipped with Meritor WABCO Electronically Controlled Air Suspension (ECAS) due to incorrect installation of the sensor, linkage, and/or Z-bracket. In these cases, the sensor was mounted aft rather than forward of the bracket, and/or the Z-bracket was attached to the axle housing outside of the correct location, which resulted in air lines or other components impeding the full travel of the arm. When the sensor, linkage, and Z-bracket are installed in the correct position, the arm should be clear of all components during travel.

6. Compare the ride height sensor position of the vehicle to [Fig. 1](#). The sensor should be installed on the forward side of the sensor bracket, and the linkage rod should be on the forward side of the Z-bracket on the axle. The linkage rod should be upright, with no fore-aft tilt, as shown in [Fig. 2](#).

If the sensor or linkage rod are out of position, reposition them to match [Fig. 1](#). While the sensor is off the vehicle, inspect it for damage. If any cracking is found on the arm or body, replace the sensor.

10. Reconnect the linkage, making sure it matches the installation in **Fig. 1**. Turn the key on and use the ECAS remote control to lift the suspension enough to remove the height blocks.

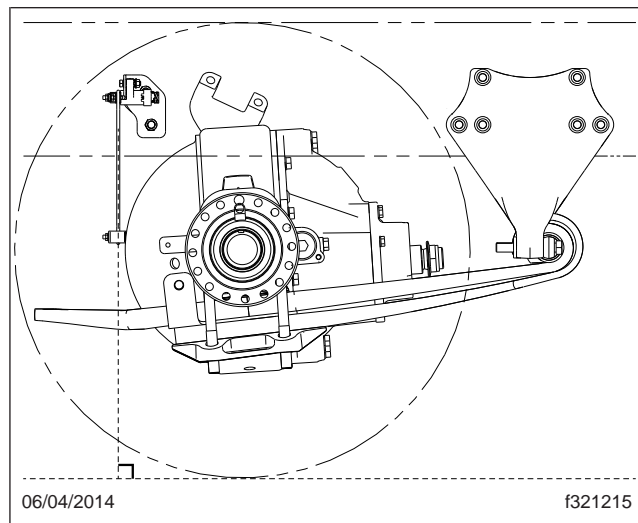
Fig. 2, The linkage rod should be perpendicular to the ground.

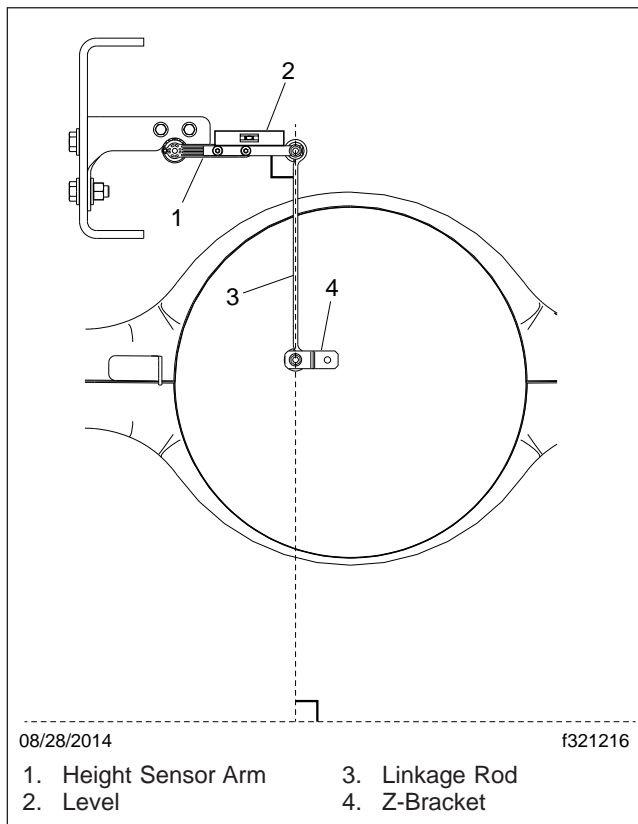
Fig. 3, Correct Position of the Arm, Linkage, and Z-Bracket

7. Check the position of the height sensor arm and linkage rod. See [Fig. 3](#). Check that the arm is level using a level, then use a plumb bob or carpenter's square to check that the linkage rod is at a 90° (right) angle to the level sensor arm.

If the arm is level, and the linkage rod is 90° to the arm and perpendicular to the ground, no further work is necessary.

If the arm is not level, and/or the linkage rod is not 90° to the arm, check the position of the Z-bracket as follows.

- 7.1 Remove the mounting stud from the Z-bracket.

- 7.2 Pin the arm to the sensor body using a 5/32-inch drill bit. If the arm isn't level when pinned, loosen the mounting fasteners and adjust the position of the sensor body on the frame bracket until the arm is level.
- 7.3 With the height sensor arm level and the linkage rod at 90°, check if the linkage end hole is within the perimeter of the Z-bracket mounting face. See **Fig. 4**.

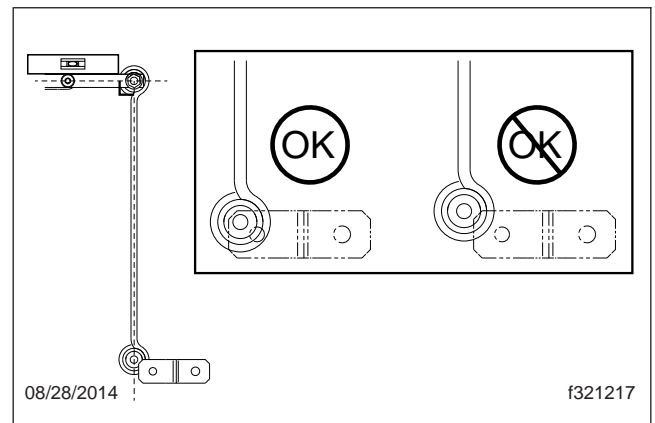
Fig. 4, Permissible Variation in Z-Bracket Position

If the end hole is within the perimeter of the Z-bracket mounting face, as shown in **Fig. 4**, the component positions are sufficient. No further work is necessary.

If the end hole is not within the perimeter of the Z-bracket mounting face, as shown in **Fig. 4**, install a new Z-bracket in the correct position. See **Positioning the Z-Bracket**.
