SI B31 04 14  
Front Axle

**SB-10057530-9006**

**Service Action: Retorque Stiffening Plate Bolts on Front and Rear Axle**

I12 (i8)

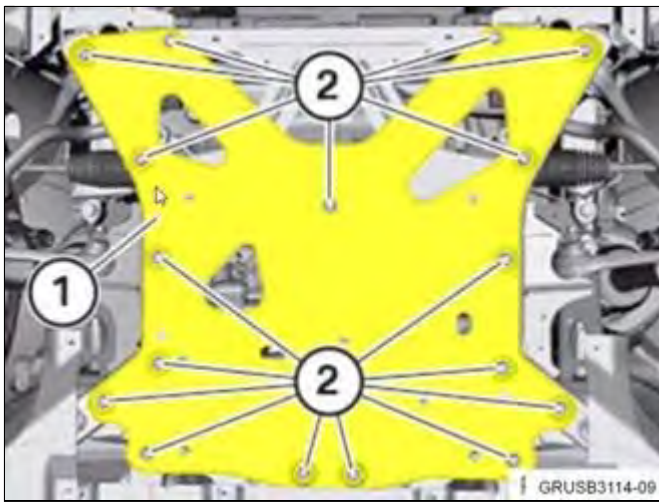
Front stiffening plate

On the front and rear axle stiffening plate bolts, the intended tightening torque may not have been reached during assembly.

Retorque all 17 bolts (2) M8x21 (Torx T50).  
Loosen them one by one (approx. 45 degrees) and retorque one by one to 28 Nm.

**Note:** Loosen and retorquing each screw before starting the next one.

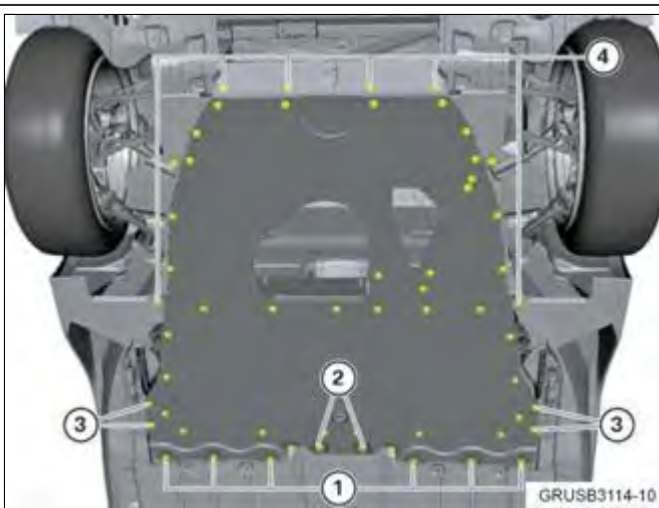
### Rear stiffening plate

**All bolts in the illustration numbered 1, 2, 3, and 4 are NOT to be retorqued!**

Retorque all bolts M8x21 (Torx T50). Loosen them one by one (approx. 45 degrees) and retorque one by one to 28 Nm.

**Note:** Loosen and retorque each screw before starting the next one.
