SUBJECT
Charging Concerns

SB-10057535-5773

MODEL
I01 (i3 and i3 REx)

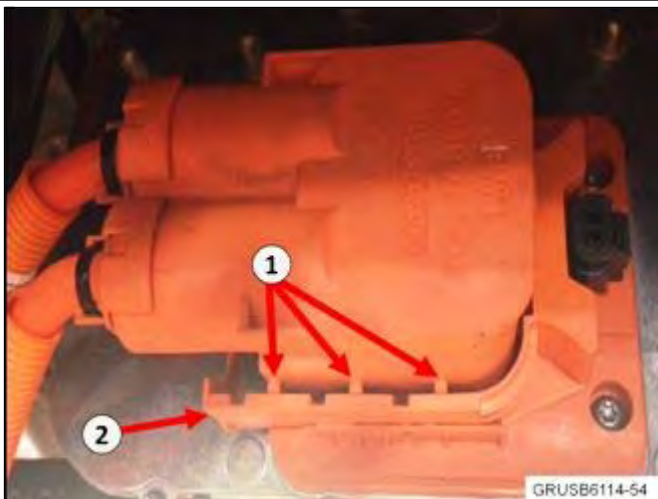
Note: Pay special attention to the locking tabs (1) on the connector to make sure they are fully seated in the sliding connector lock (2). When fully seated, the tabs are not visible.

In the image, the locking tabs are not seated, causing the connector sliding lock to bow and prevent it from locking on the connector.

If a KLE connector is found to be loose or not connected, inspect the connector and the KLE for damage to the connectors, damage to the contacts, or overheating.

If any damage or overheating is found, replace the affected HV cable and KLE.

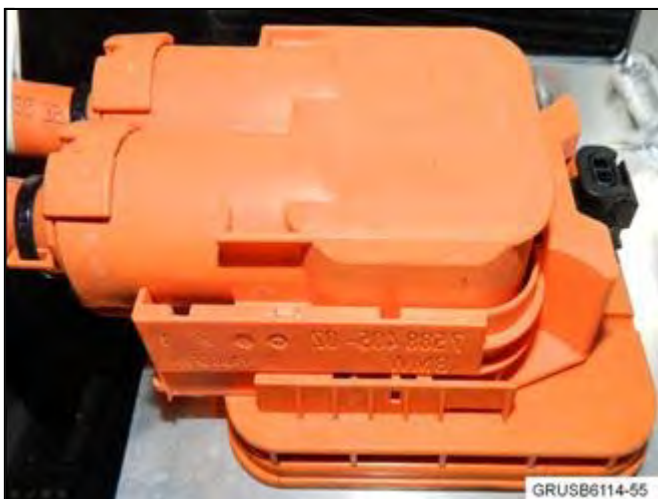
This image shows an HV connector that is properly seated and locked in place correctly.
