**SUBJECT****LED Headlight Malfunction****SB-10057566-3578****MODEL**

Vehicles produced to September 2014

With option 552 (Adaptive LED headlight)

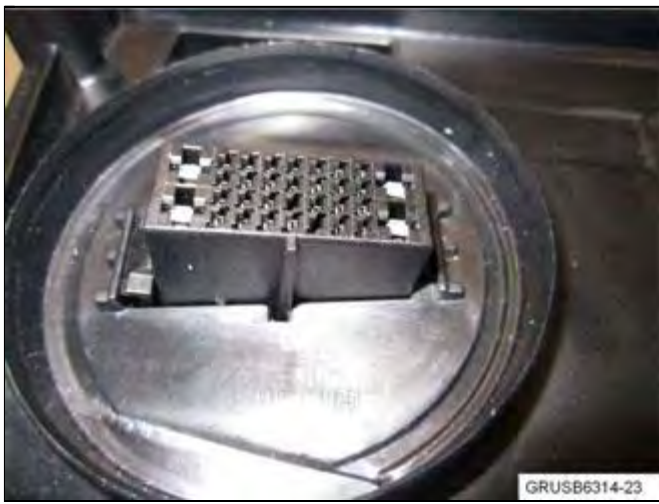
The situation above is caused by a poor connection at the LED headlight connector or LED main light module.

- After removing the LED main light module, push down on the connector.
- If the connector is pushed down as shown in the picture, continue to the next step.
