Service Bulletin

SUBJECT: Special Coverage Adjustment – Improperly Formed Hood Panel Clinch Joints

**MODELS: 2014 Buick Verano
2014 Chevrolet Sonic**

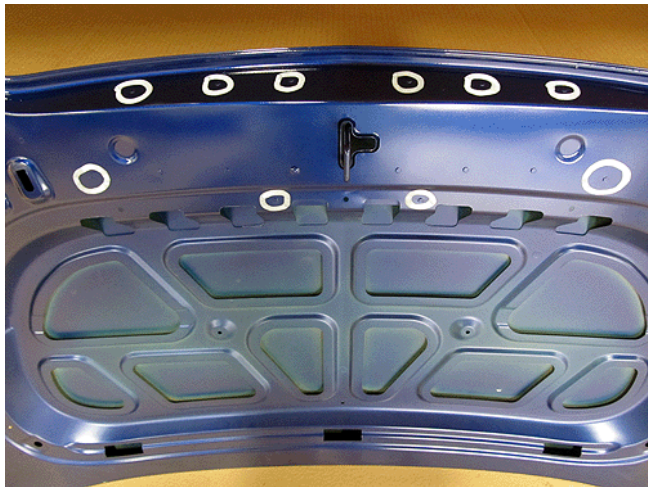
3971885

Verano Service Locations

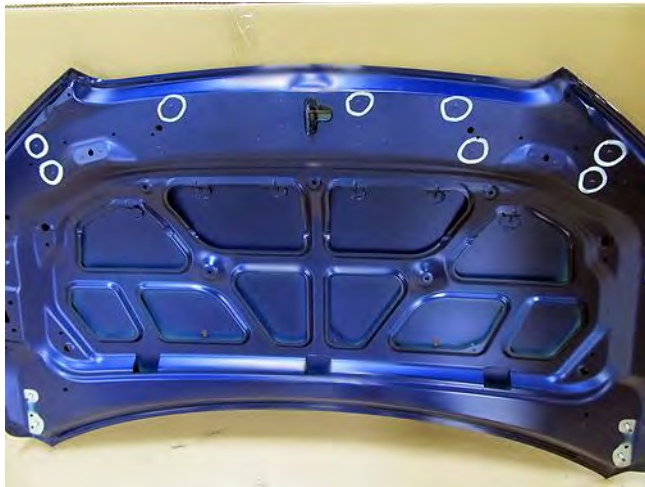
3971886

Sonic Service Locations

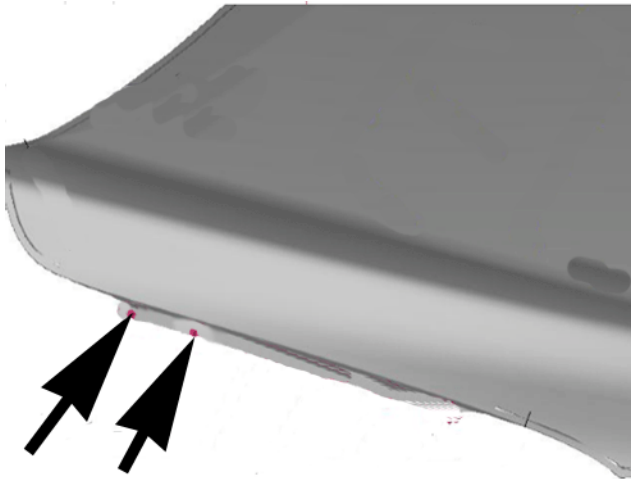
3971920

Note: On Sonic Vehicles, there are two clinch joint locations on the right rear of the hood in addition to the eight front locations.

Sonic Service Locations
