TECHNICAL BULLETIN
J047 UPS8014-3bNAS1
31 OCT 2014

Update Prior to Sale: Seat Belt Tensioner System Connector Wiring

F-TYPE (X152)

Model Year: 2014-2015
VIN: K00074-K19728

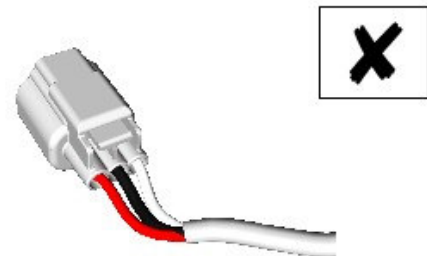
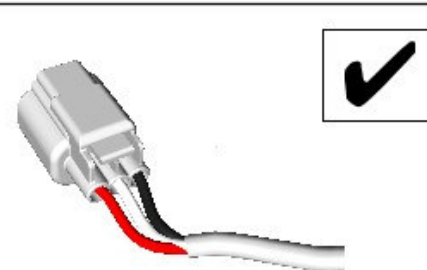
E172955

5. At the Seatbelt Tension Sensor side of connector C3R210, check that the electrical connector wires are positioned in the correct pin location as shown.

- If the wires are in the correct position, reverse steps 1-4 and release the vehicle.
- If the wires are not in the correct position, proceed to step 6.
