TECHNICAL BULLETIN  
LTB00378NAS2  
09 SEP 2014

**SECTION: 307-02C**

Transmission Oil Cooler Pipe Leak

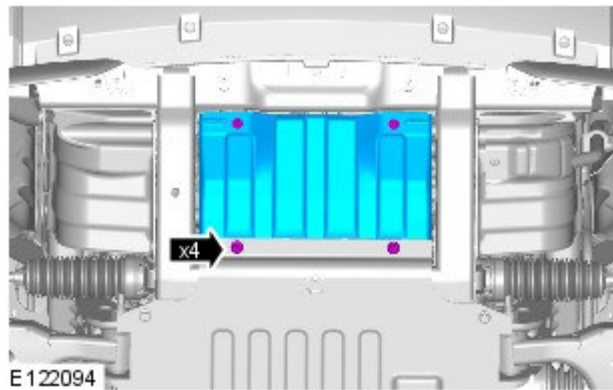
1. Raise and support the vehicle.
2. Remove the engine under tray (see TOPIx Workshop Manual, Section 501-02).
3. Remove the radiator undershield.
  - Remove the four (4) bolts.

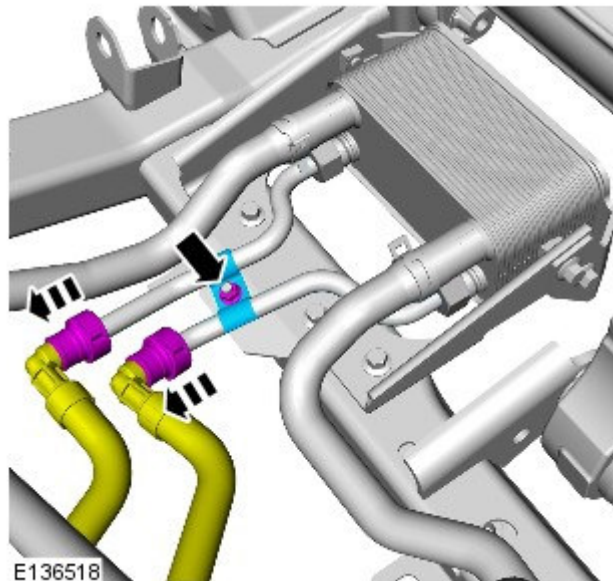
4.

Release the two transmission fluid pipes.

- Remove and discard the securing nut and securing clamp.

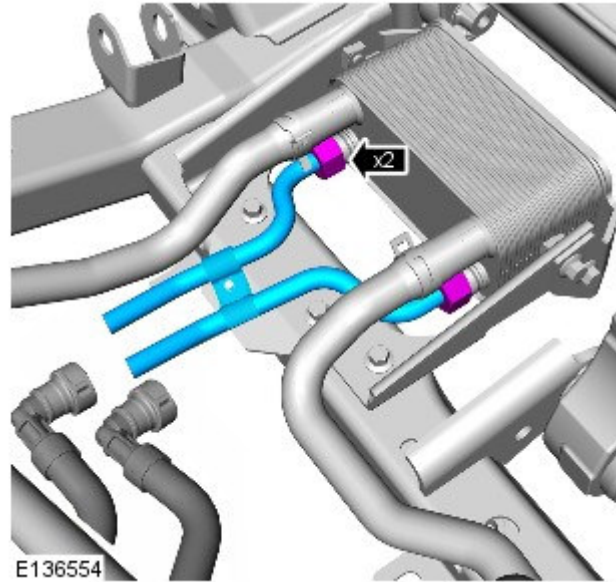
5.

Remove and discard the two transmission fluid pipes.

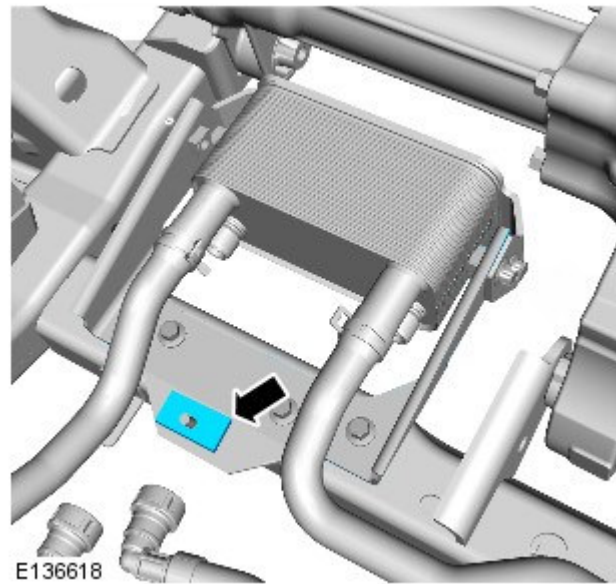
6. Install the new aluminum plate.

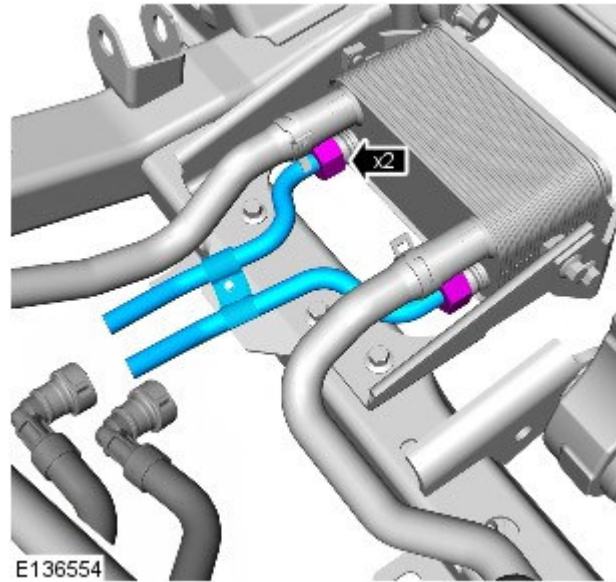
7. Install the two new transmission fluid pipes.

- Torque: 16Nm.
-

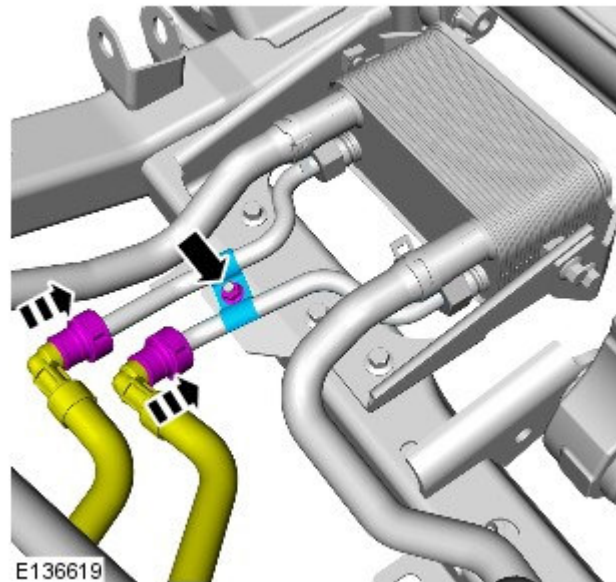
**8.** Install the two transmission fluid pipes.

- Install the new securing clamp and retaining nut.
- Torque: 10Nm.

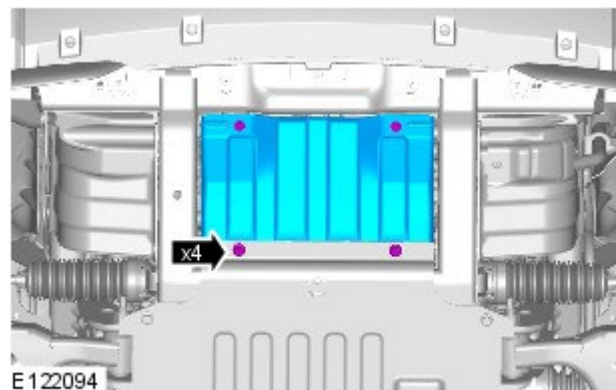
**10.** Install the radiator undershield.

1. Install the four (4) bolts.
- Torque: 10Nm.
