TECHNICAL BULLETIN

Q425NAS1

Service Action: 9 Speed Automatic Transmission Calibration

Range Rover Evoque (LV)

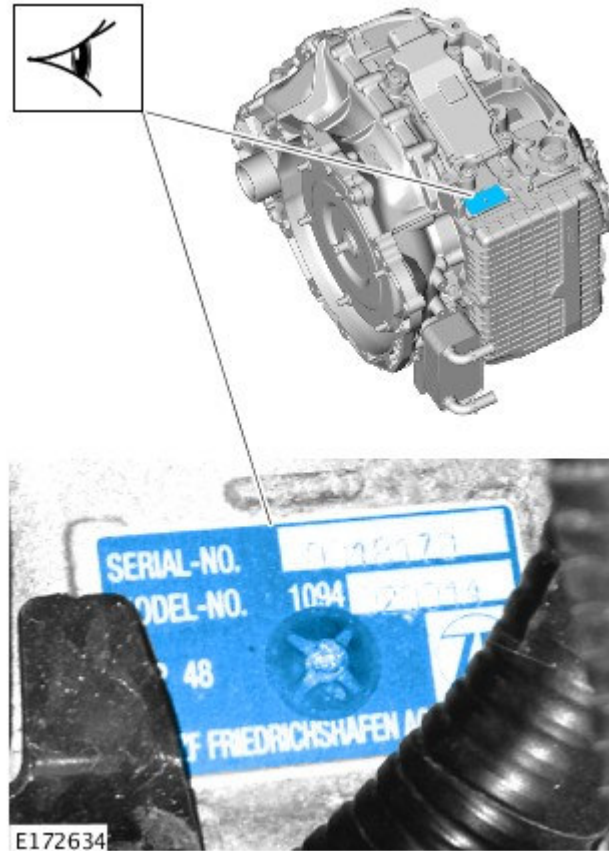
NOTE: During the software update, SDD will prompt you for the transmission serial number. This can be found by looking between the engine and the air filter housing (a lamp may be required for this operation).

Using a suitable lamp, note the transmission serial number on the repair order.
