Program Bulletin

SB-10057642-8866

SUBJECT: ECM Wire Harness Contact

MODELS: 2014 Cadillac CTS
Equipped with 3.6L Twin-Turbo Engine (LF3)

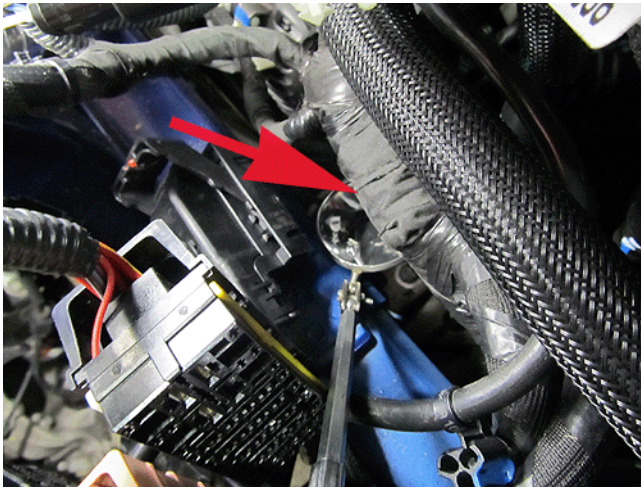
3905243

12. Inspect the wire harness conduit and insulation for damage where it contacts the bracket, repair as required. Refer to *Repairing Damaged Wire Insulation* in SI for repair instructions. The use of a mirror as, shown will, help in locating wiring damage.

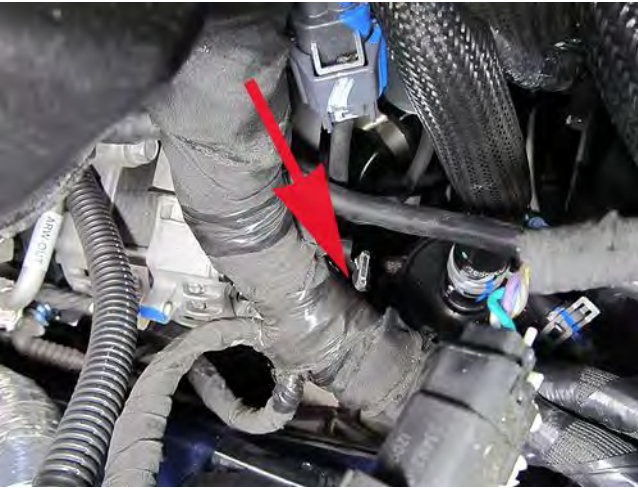
3905249

14. Inspect the position of the harness against the tab on the bracket.
