SB-10057898-6821

September 16, 2014

SUBJECT: Regional Program 14R01

Certain 2010 through 2014 Model Year Taurus and 2013 through 2014 Model Year Police Interceptor Sedan Vehicles Not Covered Under Safety Recall 14S08 License Plate Lamp Assembly Replacement

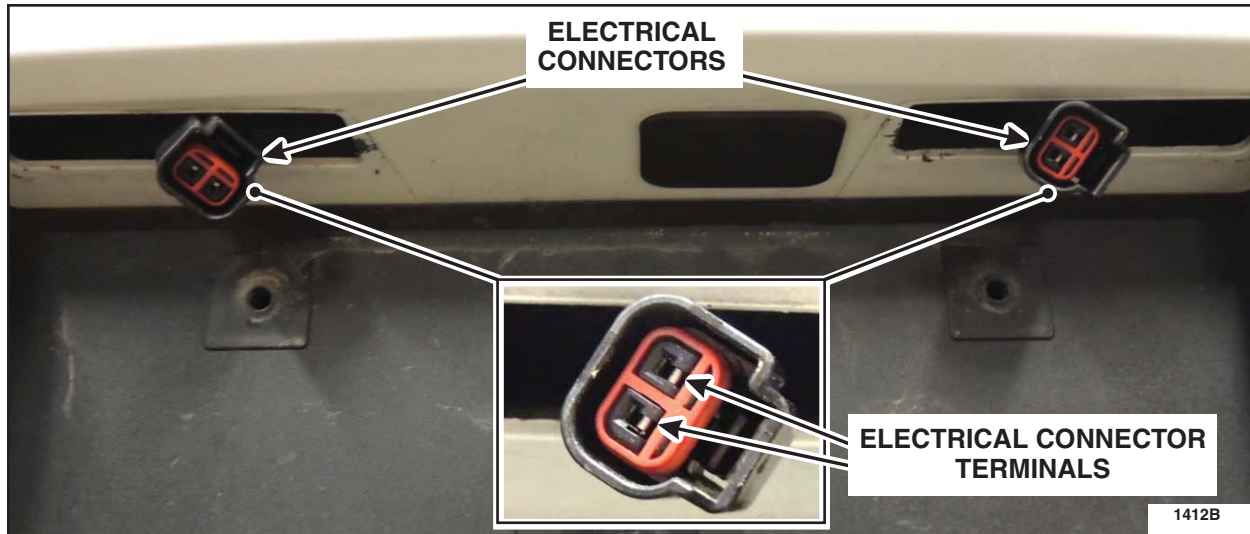
FIGURE 2

2. Inspect the license plate lamp electrical connector terminals for related damage. See Figure 2. If corrosion is found in the license plate lamp electrical connector terminals, replace the harness. (15K868).

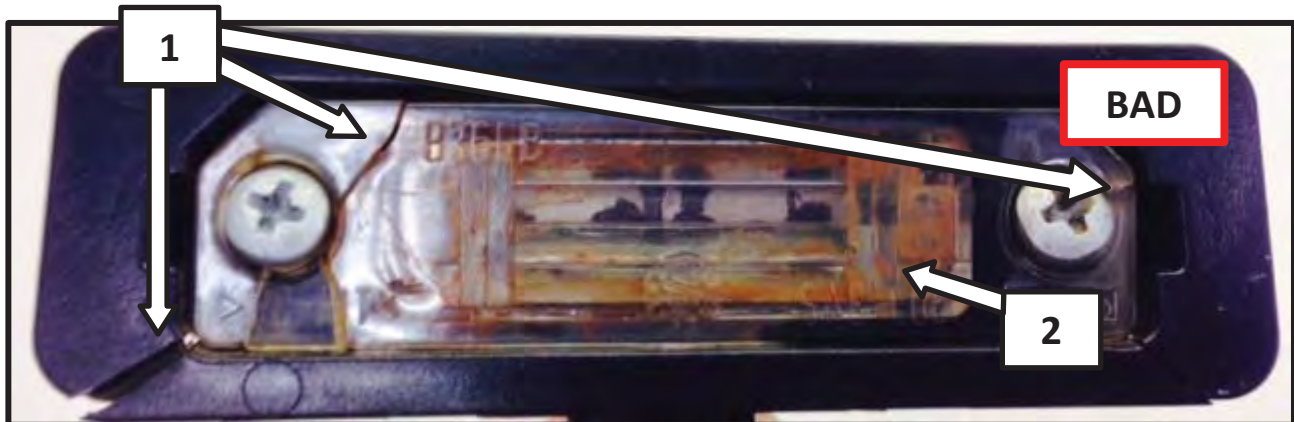
1. Visible cracks in exposed portions of the lens and housing
2. Visible corrosion behind the clear lens

If either cracks or corrosion are found during a visual inspection, contact your authorized Ford dealer for service.

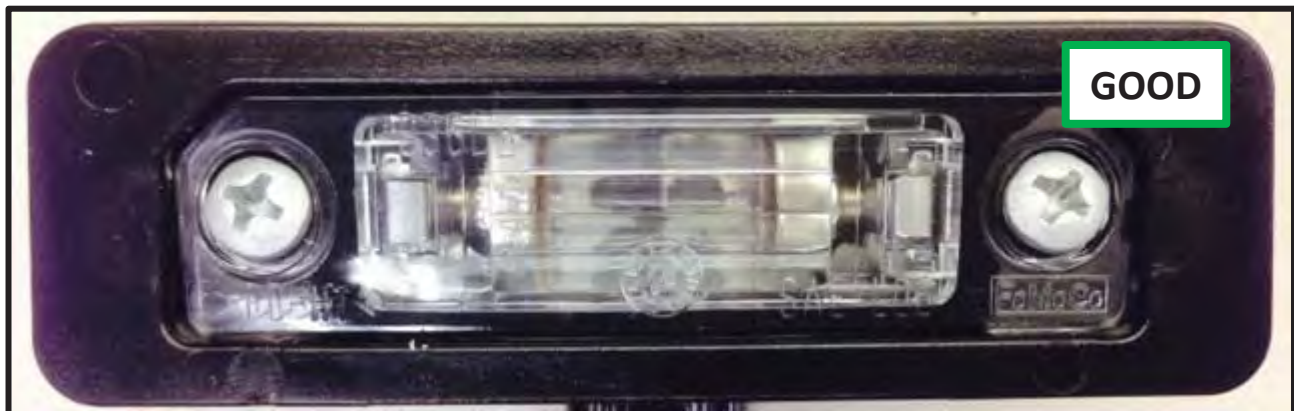
No visible cracks or corrosion
