Service Action: Drive Module Harness Edge Protection

I12 (i8)

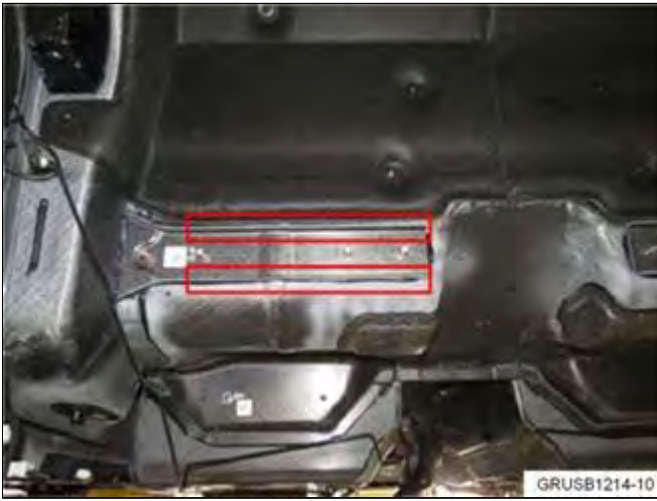
The wiring harness for the drive module (rear engine compartment) is routed in close proximity to the ISOFIX reinforcement bracket. During unfavorable conditions, the harness may rub against the bracket. Contact between the harness and bracket may produce a noticeable noise. With longer exposure, the bracket may rub through the corrugated tubing protecting the harness.

3. Cut the edge protection into two pieces, 200 mm (approximately 8") long.
4. Secure each edge protection piece to the Carbon Fiber (CFRP) flanges above and below the ISOFIX mount, as shown in red. This is located on the rear bulkhead of the vehicle.

NOTE: The CFRP flange is very sharp, so gloves should be worn for this step.
