Various Electrical Faults Caused by Shorted K-CAN2

F25 (X3)

Produced to January 13, 2014

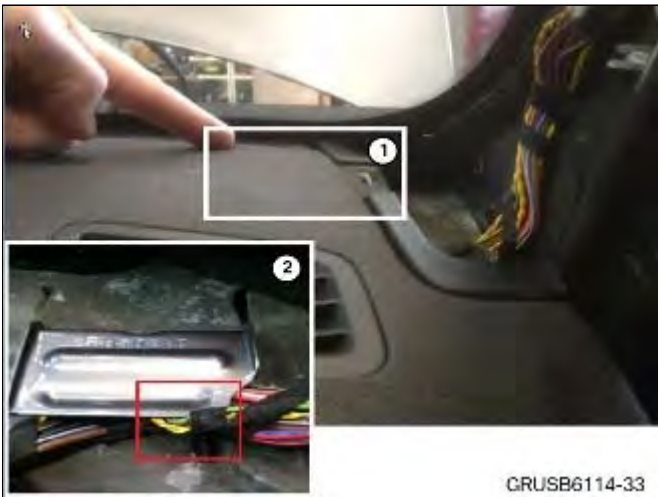
The wiring harness gets pinched between the instrument panel and the locating tab on the passenger side of the instrument panel.

<ol style="list-style-type: none"> 3. Remove the passenger side A-pillar trim panel per ISTA Repair Instruction 51 43 201. 4. Inspect the area (1) using a mirror to see if the harness is pinched and rubbing against the locating tab (2). 5. If the harness is rubbing against the tab, the instrument panel trim needs to be removed to repair and reposition the harness. Refer to ISTA Repair Instruction 51 45 030.
	<ol style="list-style-type: none"> 6. Repair and tape the harness as needed. 7. Reposition the harness away from the tab and route per the picture (1). 8. Reassemble the instrument panel trim, ensuring that during reassembly, the harness stays in place and is not pinched. Refer

Locate and repair the shorted wires. Reposition the harness.
