Charging Concerns

I01 (i3 and i3 REx)

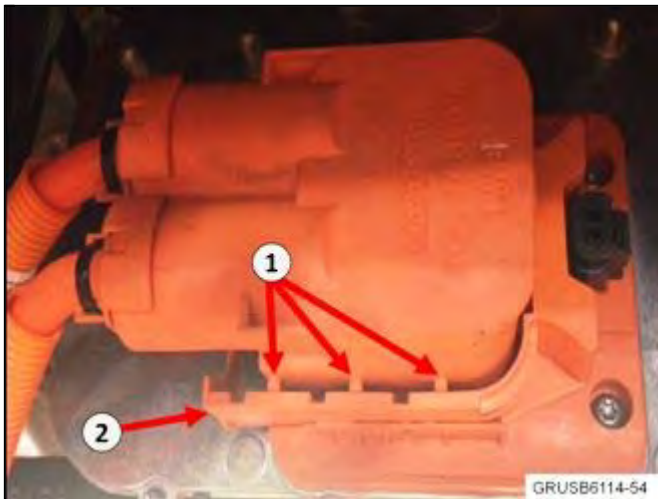
Inspect all HV connectors on the KLE for proper fit. It is possible that one of the HV connectors on the KLE is not seated fully, and in some cases, might not be connected at all.

Note: Pay special attention to the locking tabs (1) on the connector to make sure they are fully seated in the sliding connector lock (2). When fully seated, the tabs are not visible.

In the image, the locking tabs are not seated, causing the connector sliding lock to bow and prevent it from locking on the connector.

If a KLE connector is found to be loose or not connected, inspect the connector and the KLE for damage to the connectors, damage to the contacts, or overheating.

If any damage or overheating is found, replace the affected HV cable and KLE.
