SB-10058241-2847

Front Doors Will Not Latch

R60 (Cooper Countryman, Cooper S Countryman, Cooper S Countryman All 4, JCW Countryman All 4)

R61 (Cooper Paceman, Cooper S Paceman, Cooper S Paceman All 4, JCW Paceman All 4)

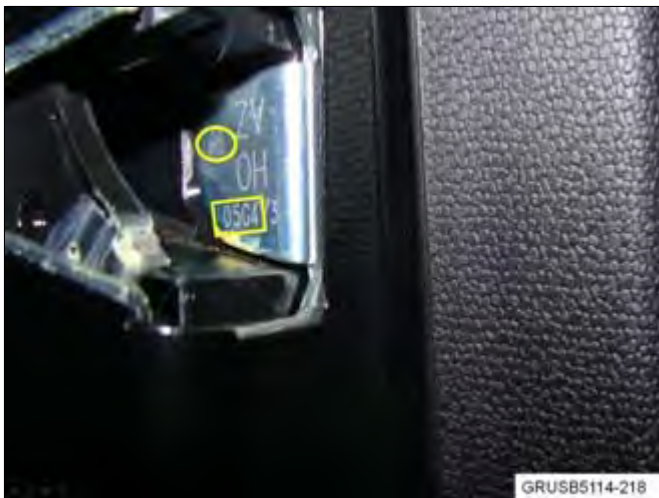
Open the door and check for the M stamping and 4-digit date code on the inside of the front door lock.

1. The picture shows the door lock with the M (Magna) and date code 05G4.

If the Magna door lock date code falls between January 20, 2014 (20E4) and February 28, 2014 (28F4), both door locks must be replaced.

Replace both front door locks based on the vendor and door lock date code.
