## SB-10058999-9512

**SUBJECT:** Transmission Harness Damage Due to Contact with Windshield Wiper Linkage and/or Unsecured Transmission Control Module (TCM)

**MODELS AFFECTED:** 3000 and 4000 Series Product Family Transmissions in Peterbilt Trucks

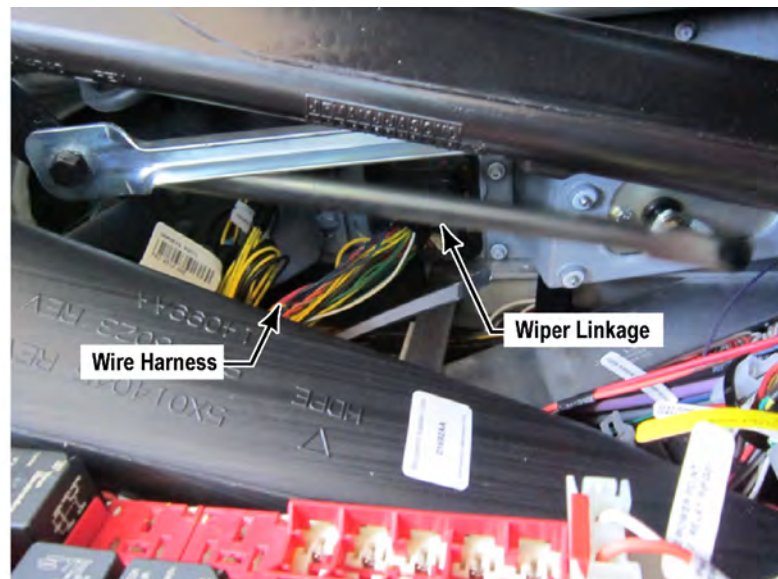
1. Some Peterbilt trucks have been built with the transmission wiring harness routed too closely to the windshield wiper linkage. When the windshield wipers are turned on, the linkage may contact the wires in the harness and rub through the insulation. This may cause intermittent shorts either to ground (when contact with wiper linkage occurs) or between multiple circuits. The wiper linkage contact can occur on the driver's or passenger's side, or both. Refer to [Figure 1](#), [Figure 2](#), and [Figure 3](#).

Figure 1. TCM Wiring Harness and Windshield Wiper Linkage

If this issue is discovered while performing customer maintenance or repair, please inform the customer that he or she should schedule an appointment with a Peterbilt dealer to address the issue.

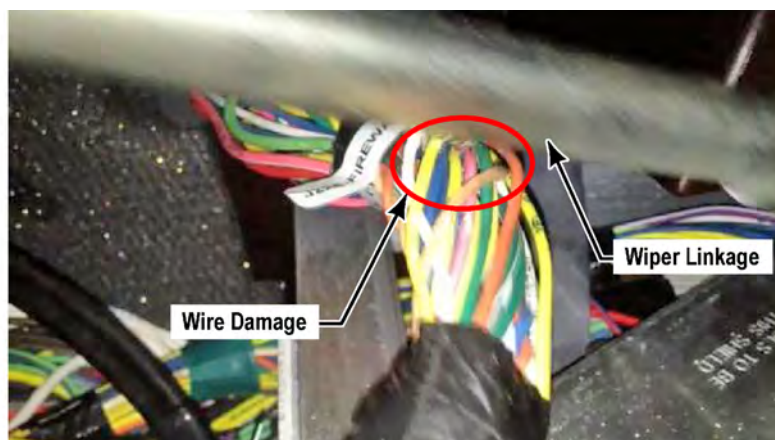
**Figure 2. Driver Side Harness**

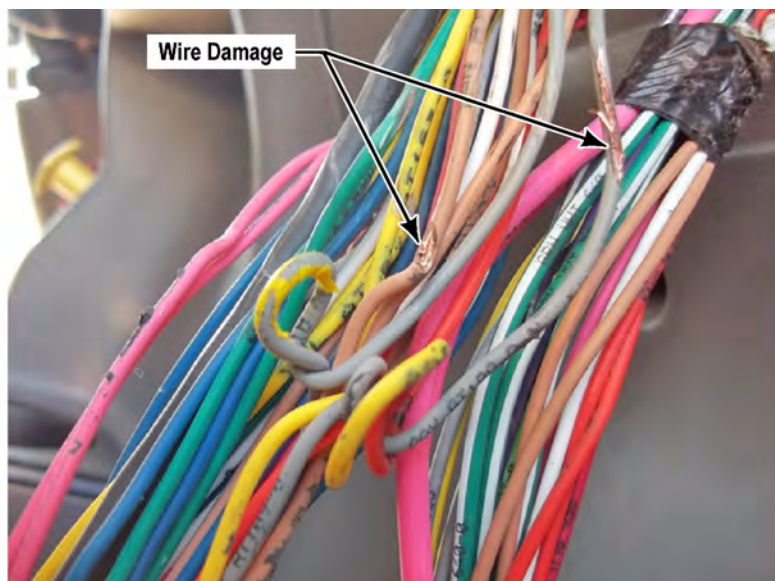
**Figure 3. Passenger Side Harness (Wiper Linkage Not Shown)**

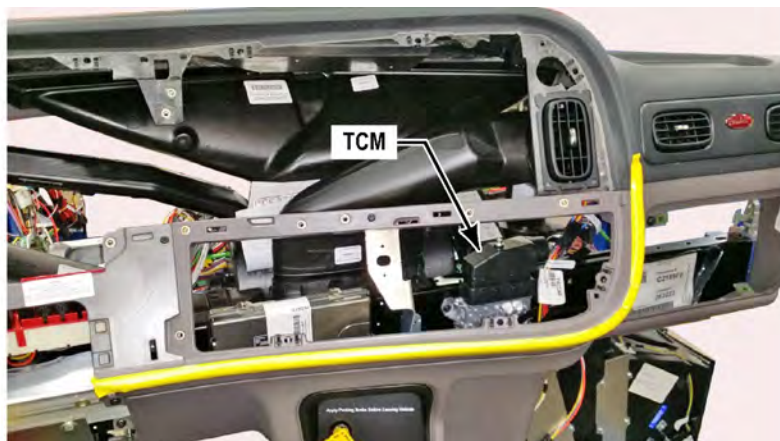
2. Some Peterbilt trucks that have a shift selector mounted on the dash “A-panel” and dual air cleaners may have a TCM that is not securely mounted in the dash. This may cause the TCM to move freely while driving. As a result, the wires entering the TCM connector can rub against metal dash supports. This can eventually lead to shorts to ground or between multiple circuits. Refer to [Figure 4](#).

**Figure 4. Disassembled Dash Board**
