# SERVICE BULLETIN

## SB-10059018-3632

| <b>VEHICLE MODEL</b> | : T2145, C2045, CX45 |
| <b>SUBJECT</b> | : <b>To change not properly heat-treated axle shafts</b> |

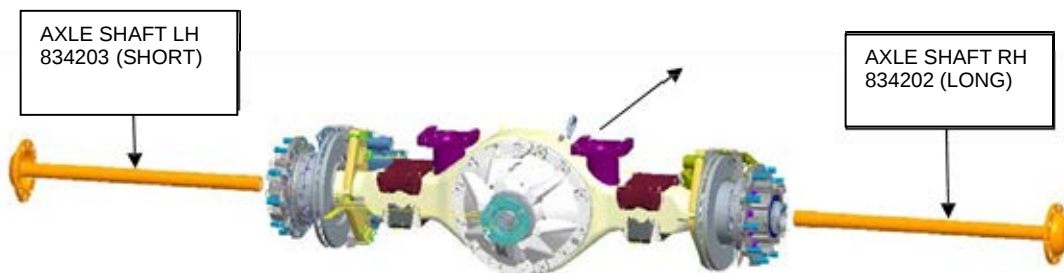
- Axle manufacturer Dana has informed Van Hool of a quality issue on the axle shafts of some drive axles. The affected axle shafts have been incorrectly heat treated what can result in early failure if the shafts are subjected to extreme or adverse operating conditions.
- To address this issue, Dana and Van Hool are conducting a field change program to replace these axle shafts. Terms and conditions are explained further on under "Warranty".
- Owners and operators of the affected units should replace the axle shafts.
- Refer to the step-by-step instructions explained in this Service bulletin.

1. Remove the 8 x Verbus Ripp retaining screws securing the axle shaft to the hub.
2. Place a drip tray or spill cloth under the flange end of the axle shaft to catch any oil which may be lost as the axle shaft is extracted.
3. Insert 2 x M10 x 1.5 “jacking screws” into the 2 threaded holes in the axle shaft flange. This will pull the axle shaft flange away from the hub face.
4. Pull the axle shaft from the axle.
5. Clean the face of the hub and apply a thin bead of soft sealant (Loctite 518 or similar).
6. Identify the correct position of the axle shafts. On the figure below it is shown that the shorter shaft part No.834203 is fitted at the LH side of the vehicle/axle. The longer shafts part No.834202 is fitted at the RH side of the vehicle/axle.

7. Insert the new axle shaft into the axle, aligning the axle shaft splines with the differential side gear. Some rotation of the axle shaft will be necessary to align the splines.
