Technical product information

Transaction No.: 2032773/2

New Continental GT front seat belt/s twisted

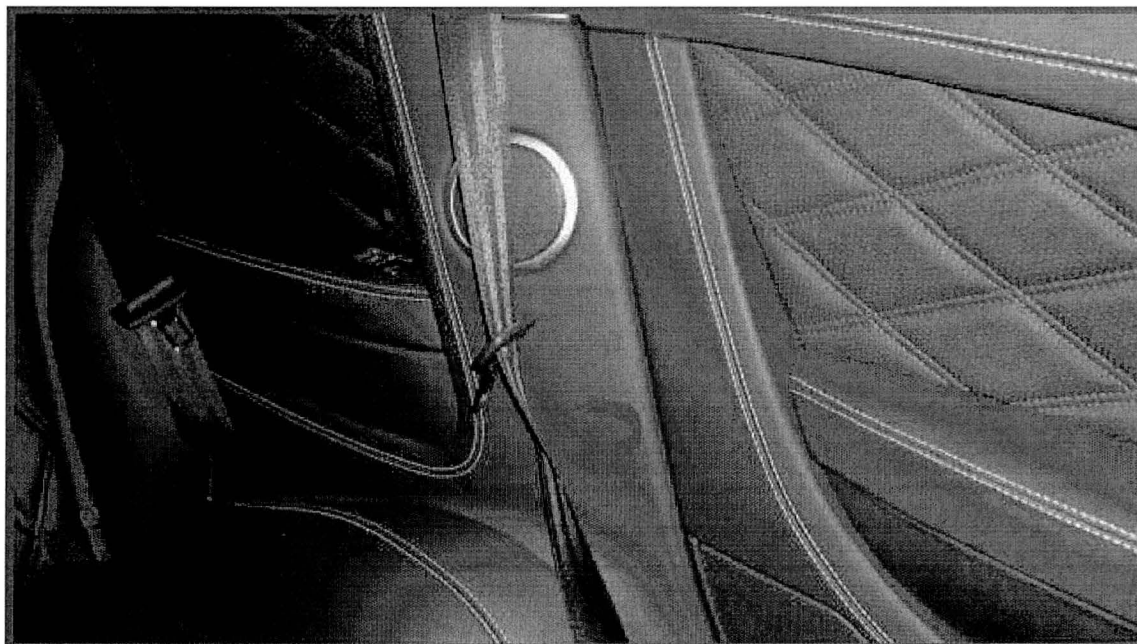
Figure 1

The front seat belt webbing is twisted (Figure 1), this is evident in both the stowed position and also when the seat belt is worn.

The seat belt webbing twists on retraction, this is due to the gap between the seat belt webbing guide and the webbing being out of tolerance.

The modification within this TPI should be applied to both the right and left hand side regardless if only one side is at fault.

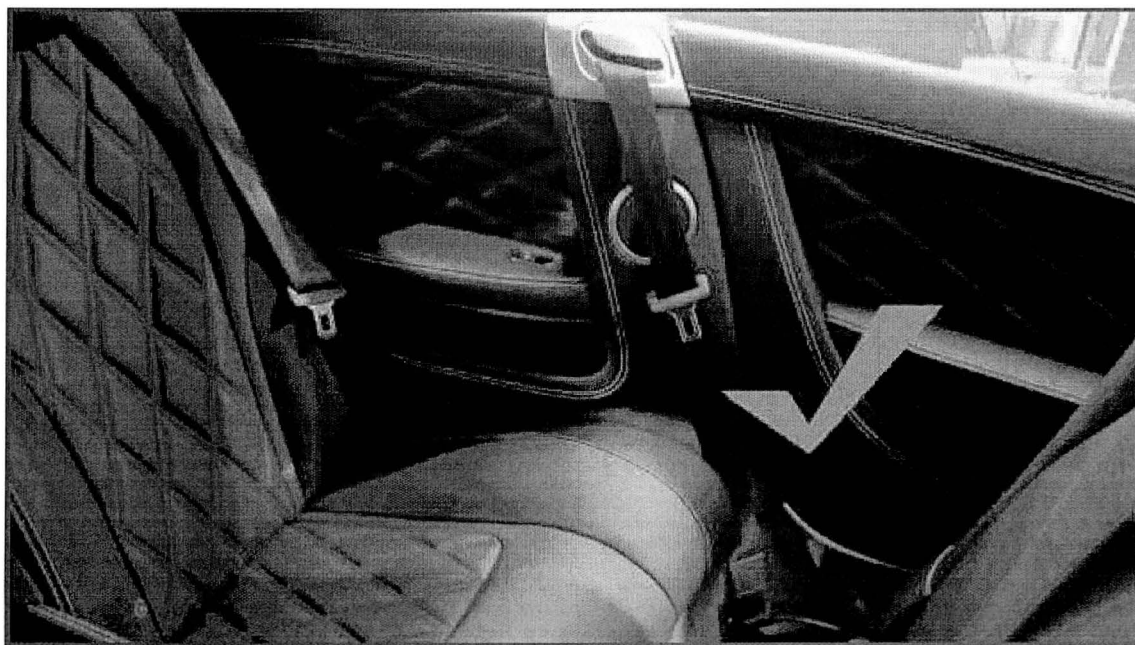
The front seatbelts in the stowed position should be as shown in Figure 2
