<b>Subject:</b> <b>MASTER WARNING LIGHT IS ON AND INSTRUMENT CLUSTER WARNING MESSAGE IS DISPLAYED (DTC P1794 AND P2502)</b>	<b>Bulletin No:</b> 01-001/14
	<b>Last Issued:</b> 02/04/2014

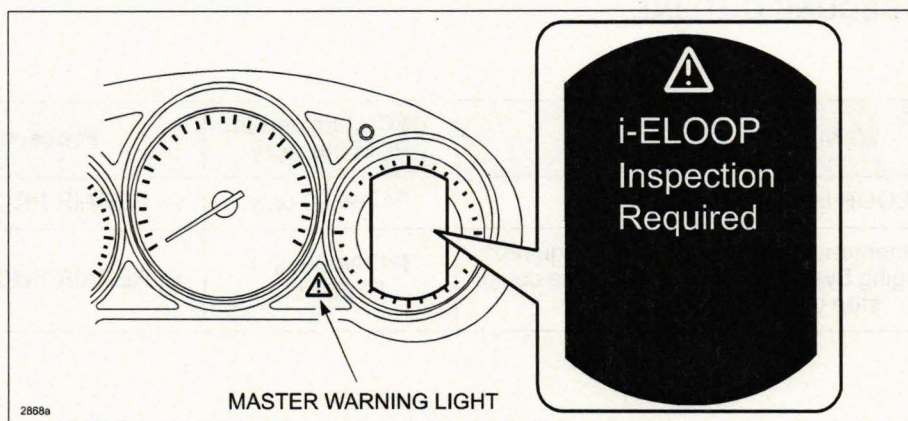
- Warning message "i-ELOOP Inspection Required" is displayed in the instrument cluster information display while driving.
- The Master warning light will be illuminated.

- DTC P1794:00 (Capacitor (i-ELOOP) system: Capacitor (i-ELOOP) malfunction) will be stored in PCM memory.

Customers having this concern should have their vehicle repaired using A. REPAIR PROCEDURE.

1. Verify DTC P1794:00 is stored in PCM memory.
2. Select M-MDS initial screen > "Datalogger" > "Module" > "PCM" > PID "CAP\_SYS\_16" and read the value.
3. Does the "CAP\_SYS\_16" show ON?
  - Yes - Proceed to step 4.
  - No - This service bulletin does not apply. Refer to MS3 online or Workshop Manual (section 01-02 DTC P1794:00 [SKYACTIV-G 2.5]).
4. Reboot the IDS to clear memory before reprogramming.
5. Using IDS 87.04 or later software, reprogram the PCM to the latest calibration following the "Module Reprogramming" procedure.

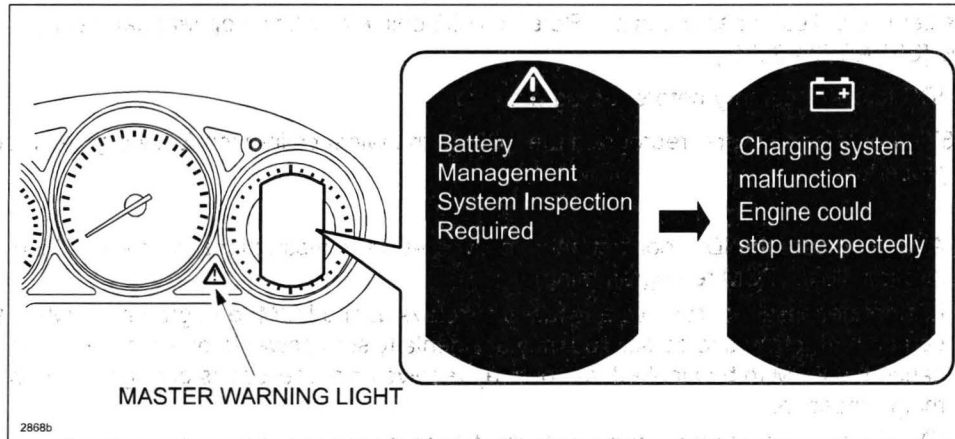
- a. Warning message "Battery Management System Inspection Required" and then "Charging System Malfunction/Engine could stop unexpectedly" is displayed in the instrument cluster information display after driving in the rain.
- b. The Master warning light will be illuminated.

- c. The following DTCs are stored in PCM memory:
- DTC P1794:00 - Capacitor (i-ELOOP) system: Capacitor (i-ELOOP) malfunction
  - DTC P2502:00 - Generator system: Malfunction in voltage generated by generator

Customers having this concern should have their vehicle repaired using B. REPAIR PROCEDURE.

1. Verify DTC P1794:00 and P2502:00 are stored in PCM memory.
2. Select M-MDS initial screen > "Datalogger" > "Module" > "PCM" > PID "CAP\_SYS\_13" and read the value.
3. Does the "CAP\_SYS\_13" show ON?
  - Yes - Proceed to step 4.
  - No - This service bulletin does not apply. Refer to MS3 online or Workshop Manual (section 01-02 DTC P1794:00 [SKYACTIV-G 2.5]) and (section 01-02 DTC P2502:00 [SKYACTIV-G 2.5]).
4. Reboot the IDS to clear memory before reprogramming.
5. Using IDS 88.03 or later software, reprogram the PCM to the latest calibration following the "Module Reprogramming" procedure.
