Service Bulletin

Subject: MASTER WARNING LIGHT IS ON AND INSTRUMENT CLUSTER WARNING MESSAGE IS DISPLAYED (DTC P1794 AND P2502)	Bulletin No: 01-001/14
	Last Issued: 01/24/2014

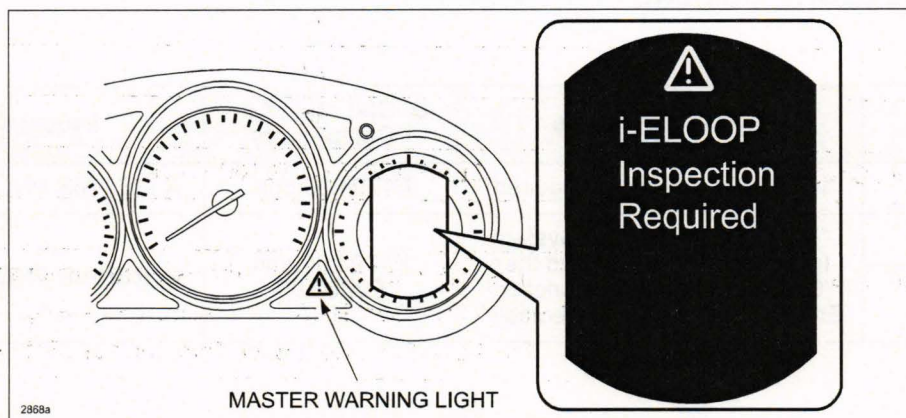
- a. Warning message "i-ELOOP Inspection Required" is displayed in the instrument cluster information display while driving.
- b. The Master warning light will be illuminated.

- c. DTC P1794:00 (Capacitor (i-ELOOP) system: Capacitor (i-ELOOP) malfunction) will be stored in PCM memory.

Customers having this concern should have their vehicle repaired using A. REPAIR PROCEDURE.

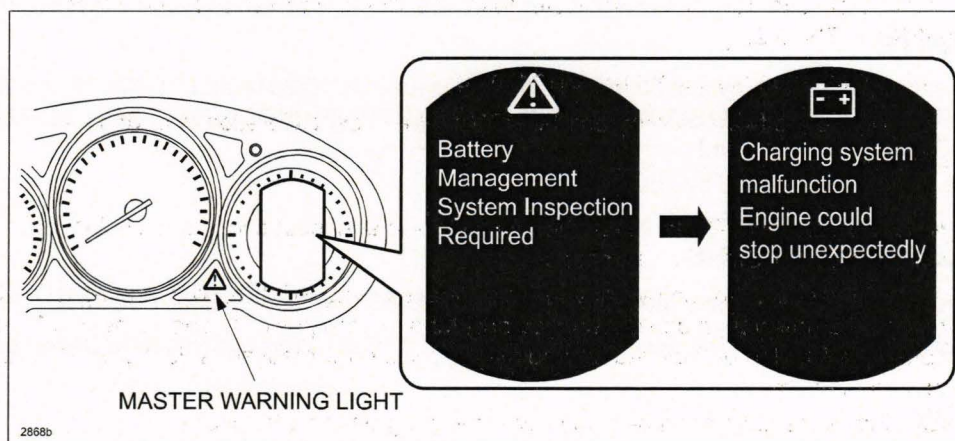
- Warning message "Battery Management System Inspection Required" and then "Charging System Malfunction/Engine could stop unexpectedly" is displayed in the instrument cluster information display after driving in the rain.
- The Master warning light will be illuminated. **The Mazda6 warning indicator light and warning messages are shown below:**

- The following DTCs are stored in PCM memory:
 - DTC P1794:00 - Capacitor (i-ELOOP) system: Capacitor (i-ELOOP) malfunction
 - DTC P2502:00 - Generator system: Malfunction in voltage generated by generator

Customers having this concern should have their vehicle repaired using B. REPAIR PROCEDURE.
