Service Bulletin

Subject: INFORMATION DISPLAY SHOWS "FOW INSPECTION REQUIRED" AND DTC C1A67:78 IS STORED	Bulletin No: 01-016/14
	Last Issued: 07/08/2014

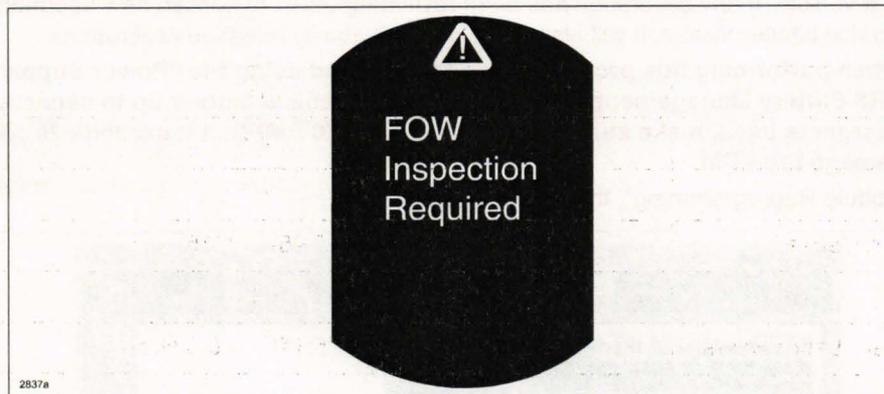
Some customers may experience a MRCC malfunction when driving long distances with MRCC set. Instrument cluster information display shows "FOW INSPECTION REQUIRED" and DTC C1A67:78 (Radar sensor axis is deviated) is stored. This is caused by MRCC no obstacle detection during a long drive.

Customers having this concern should have their vehicle repaired using the following repair procedure.

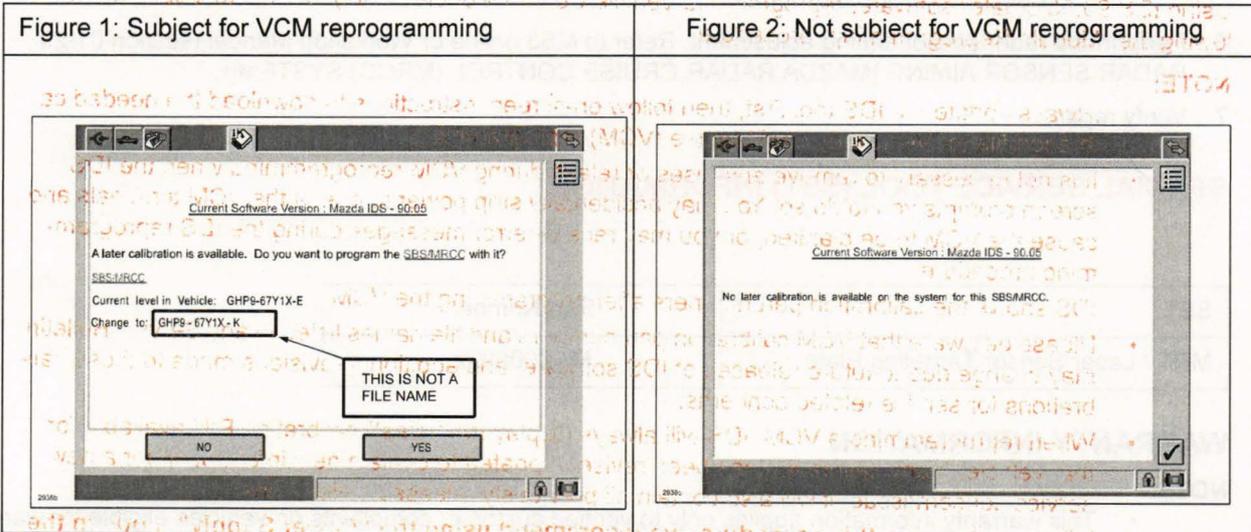
- b. Either of the following screens (Figure 1 or 2) is displayed.
- If the Figure 1 is displayed, the VCM is before the latest calibration. Click "YES" and follow the M-MDS instructions to reprogram the VCM.
 - If the Figure 2 is displayed, the VCM is already the latest calibration. This Service Information does not apply and refer to Workshop Manual for troubleshooting and repair.

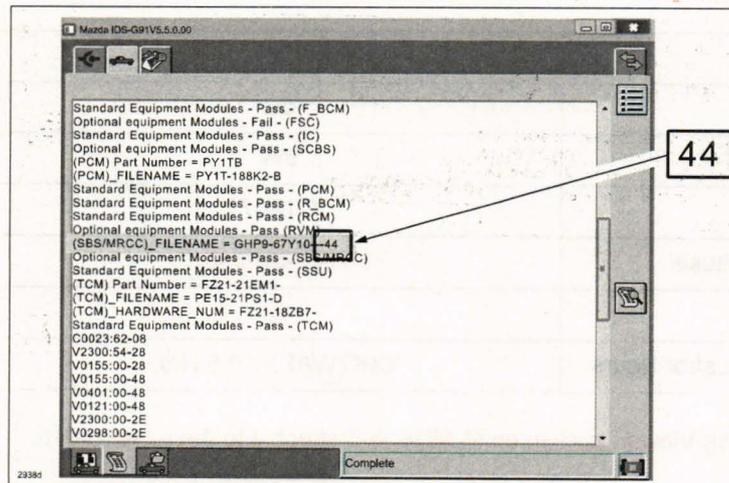
- c. After reprogramming, close the session. Then, open a new session and go to the "Log Viewer" screen. The programmed file name is displayed as shown in figure below. If the last two letters are "44", the reprogramming has been successfully completed.
