Subject: CHECK ENGINE LIGHT ON WITH DTC P2610	Bulletin No: 01-017/14
	Last Issued: 10/17/2014

- 2013-**2016** CX-5
- 2014-**2016** Mazda6
- 2014-**2015** Mazda3

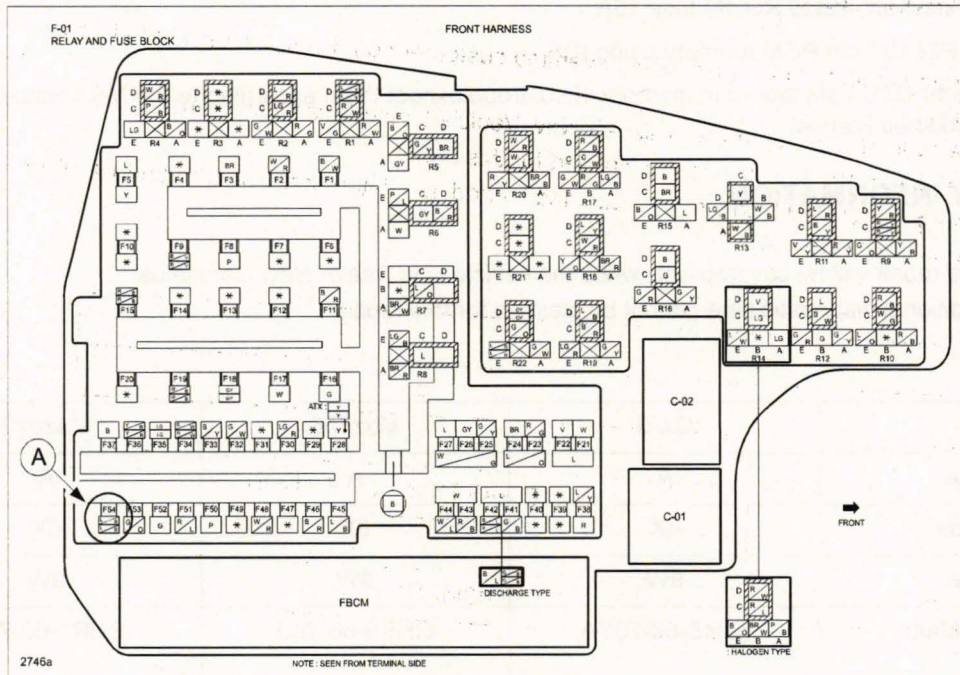
Some vehicles may experience MIL illumination with DTC P2610 (Instrument cluster internal engine off timer performance problem) stored in memory after engine start and room fuse 15A (A) removed.

1. Verify DTC P2610 is stored in PCM memory.
2. With the ignition off, install ROOM fuse 15A.
3. Clear DTC P2610 from PCM memory using IDS.
4. Verify no other DTCs are stored in memory. If so, troubleshoot them according to the MS3 online instructions or Workshop Manual.

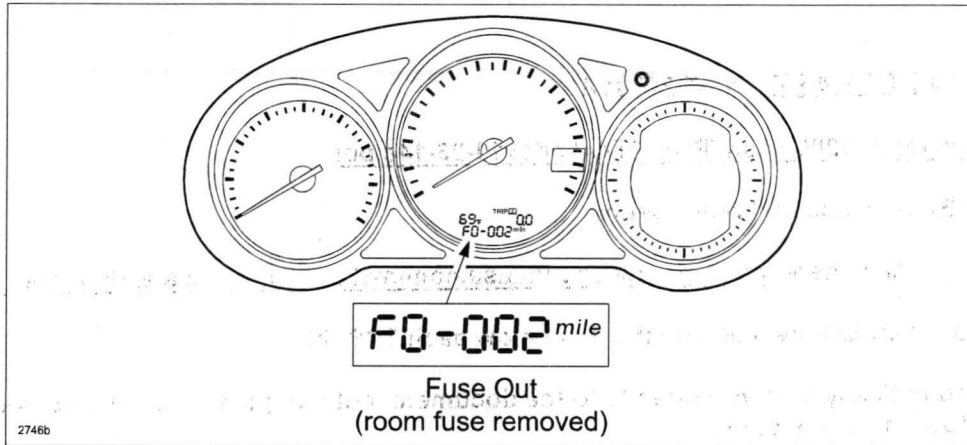
NOTE: The odometer will display "F0-002" during transport mode (room fuse 15A removed). Transport mode is canceled when room fuse 15A is installed or the vehicle odometer is more than 12.4mi (20km).
