<b>Subject:</b>  CHIRP NOISE FROM REAR SHOCK ABSORBERS	<b>Bulletin No:</b> 02-003/14
	<b>Last Issued:</b> 10/23/2014

2014-**2015** CX-5 vehicles with VINs between JM3 KE \*\*\*\*\* 387092 and JM3 KE \*\*\*\*\* 490721 (**produced between September 2, 2013 and June 05, 2014**)

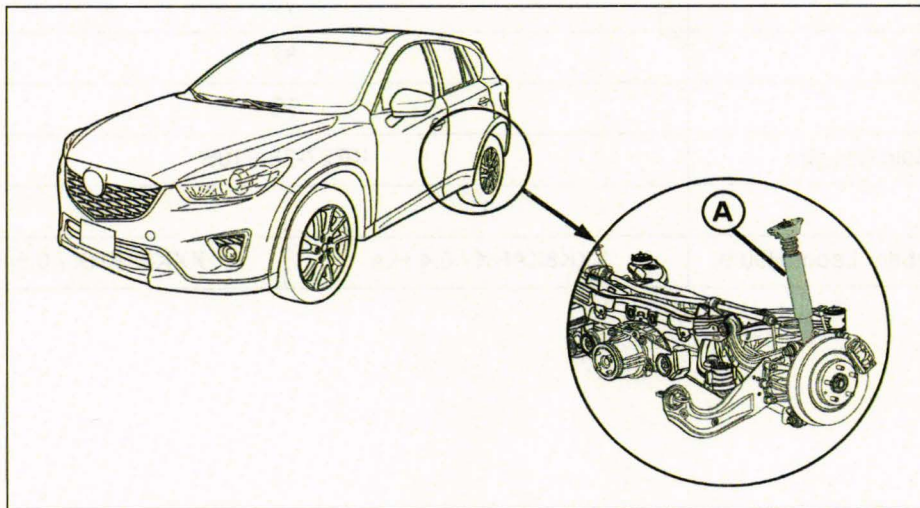
Some vehicles may exhibit a chirp noise from the rear shock absorbers (A) when driving on a rough road or passing over a speed bump. Visual inspection of the shock absorbers show no external damage or oil leakage.

1. Verify customer concern.
2. Replace the rear shock absorber. Refer to MS3 online or Workshop Manual (section 02-14 REAR SHOCK ABSORBER REMOVAL/INSTALLATION).

**NOTE:** Only replaced the affected side.
