# **Service Bulletin**

Subject:	Bulletin No:	02-004/14
STEERING WHEEL OFF CENTER WITHOUT DRIFT OR PULL	Last Issued:	11/4/2014
	11.

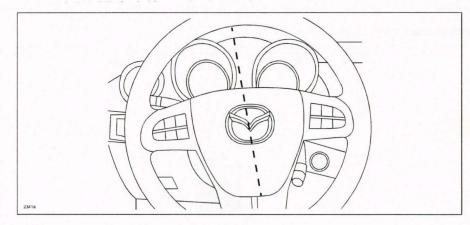
Some customers may complain that the steering wheel is off center more than 3° even when driving straight on a flat road.

Customers having this concern should have their vehicle repaired using the following repair procedure.
