# Service Bulletin

<b>Subject:</b>  WHINING NOISE FROM AUTOMATIC TRANSAXLE	<b>Bulletin No:</b> 05-004/14
	<b>Last Issued:</b> 03/19/2014

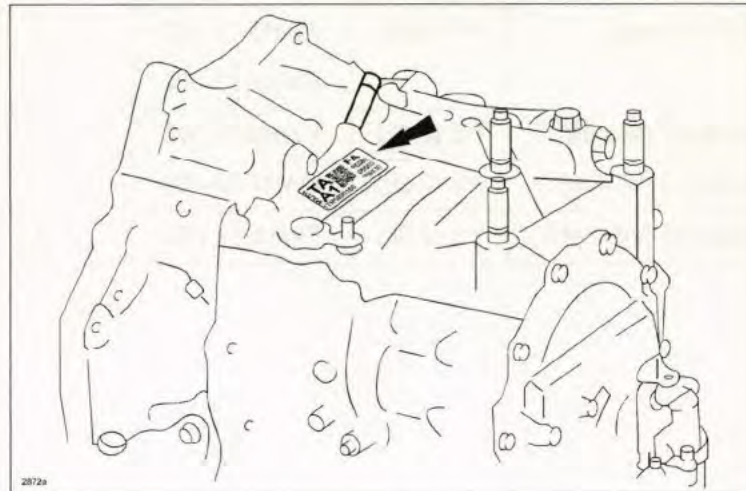
This is caused by a damaged bearing in the transaxle due to improper configuration of the transaxle case. A modification has now been implemented on automatic transaxles with the serial number TR1111680 and higher or TD1104906 and higher. The serial number can be found on top of the transaxle case near the manual shaft lever.

1. Verify customer concern.
2. Replace the 6AT assembly with a new one according to MS3 online instructions or Workshop Manual section 05-17.
3. Verify repair.
