### **SERVICE BULLETIN RELEASE - 03/05/2014**

**WHINING NOISE FROM AUTOMATIC TRANSAXLE**

**Bulletin No:** 05-004/14**Last Issued:** 03/05/2014**APPLICABLE MODEL(S)/VINS**

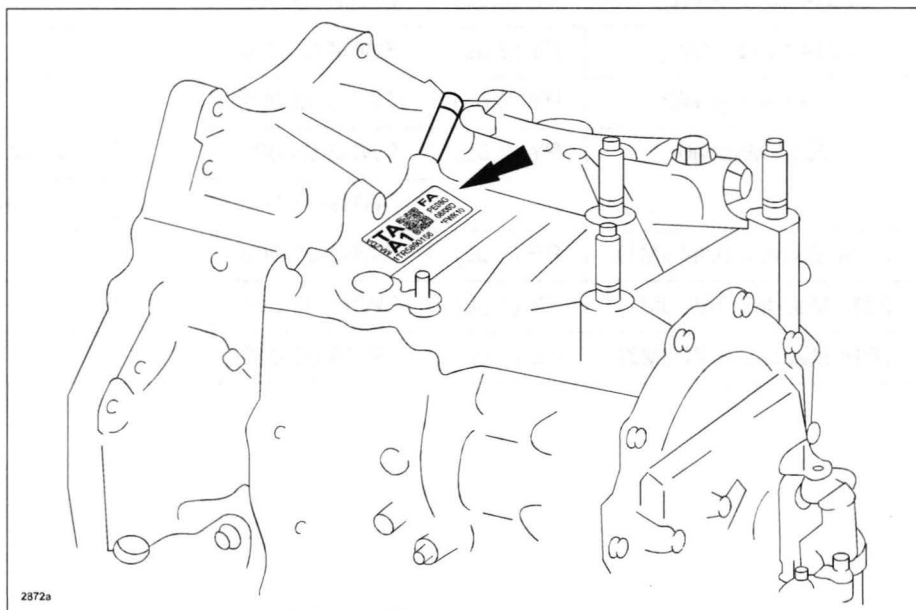
This is caused by a damaged bearing in the transaxle due to improper configuration of the transaxle case. A modification has now been implemented on automatic transaxles with the serial number TR1111680 and higher or TD1104906 and higher. The serial number can be found on top of the transaxle case near the manual shaft lever.

1. Verify customer concern.
2. Replace the 6AT assembly with a new one according to MS3 online instructions or Workshop Manual section 05-17.
3. Verify repair.
