SERVICE BULLETIN RELEASE - 04/09/2014

05-005/14 – MULTI-MODEL (WITH SKYACTIV 6AT) - CHECK ENGINE LIGHT AND AUTOMATIC TRANSAXLE WARNING LIGHT ON WITH DTC P0842, P0847, P0872 AND/OR P0877 STORED IN TCM MEMORY

Subject: CHECK ENGINE LIGHT AND AUTOMATIC TRANSAXLE WARNING LIGHT ON WITH DTC P0842, P0847, P0872 AND/OR P0877 STORED IN TCM MEMORY	Bulletin No: 05-005/14
	Last Issued: 04/09/2014

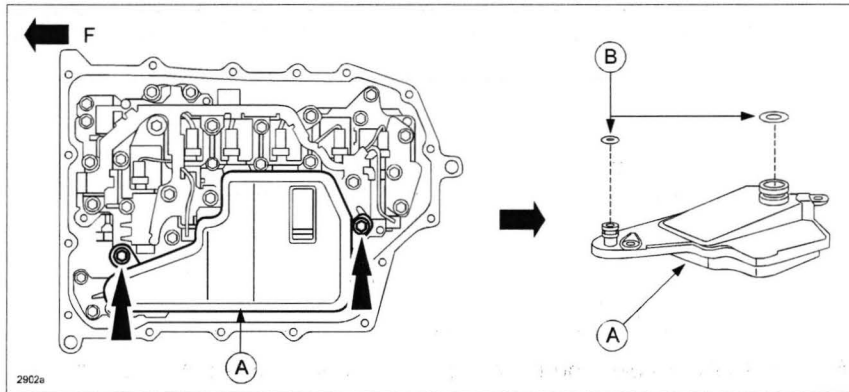
4. Remove the oil strainer (A) and the oil strainer O-rings (B) from the transaxle.
F=Front of vehicle

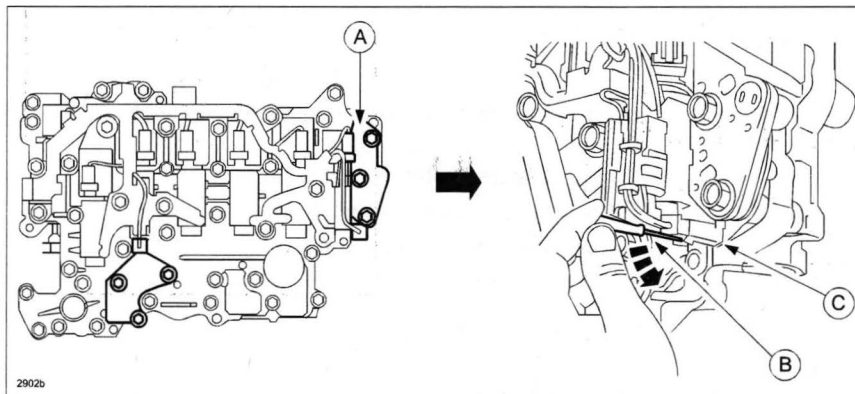
- a. At oil pressure switch A, insert a precision flathead screwdriver (B) and move it in the direction of the arrow in the figure to disconnect the oil pressure switch A connector (C).

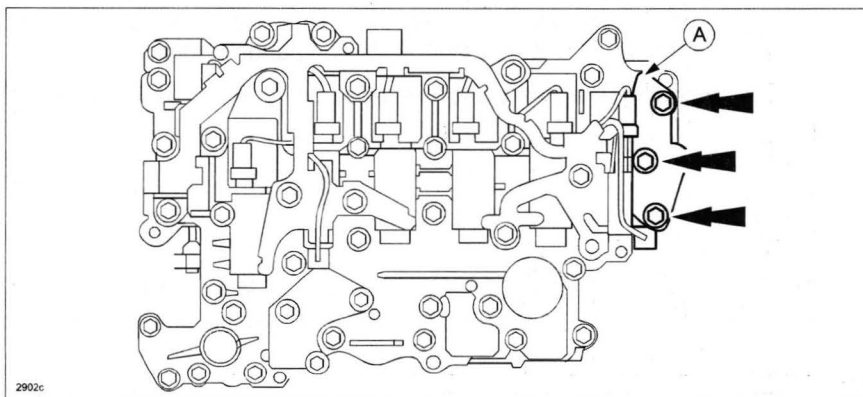
- b. Remove the bolts for oil pressure switch A.

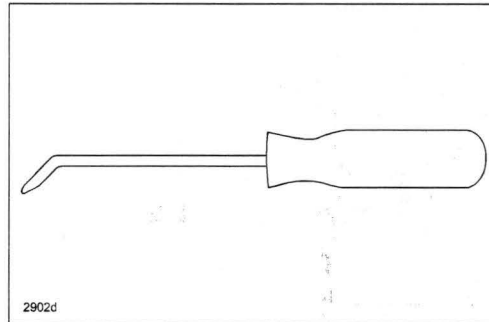
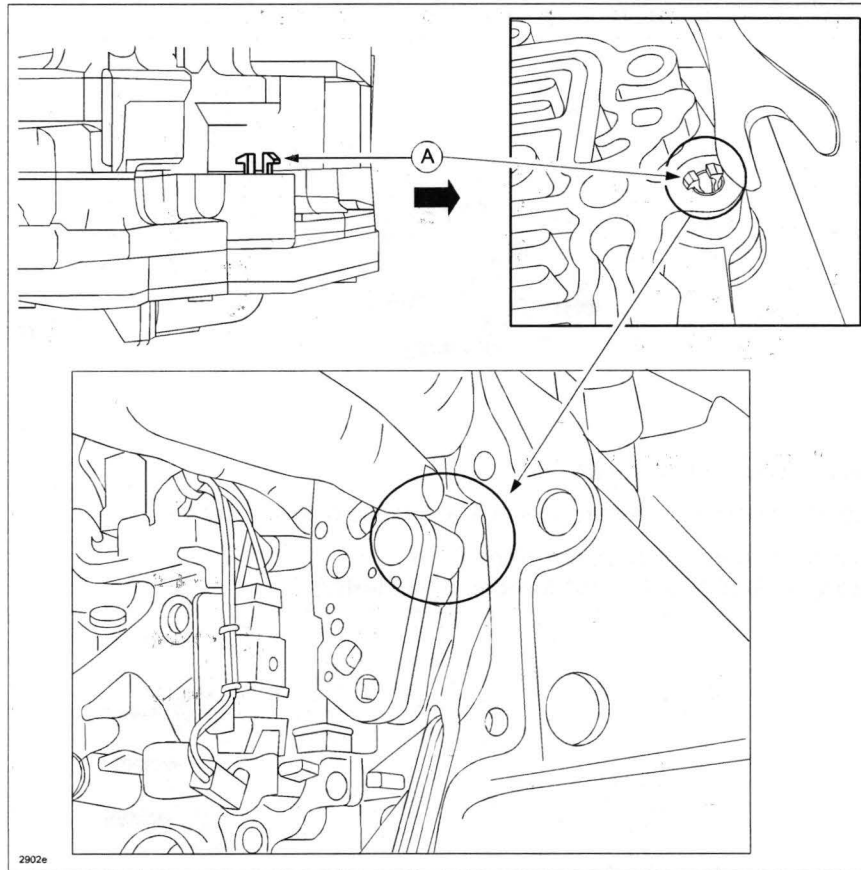
- c. Detach the tab shown and remove oil pressure switch A from the control valve body.
1. Using an appropriate tool (such as a fastener remover), push the tab (A) of oil pressure switch A.

CAUTION: If the tab is broken during removal, make sure to remove the broken pieces.

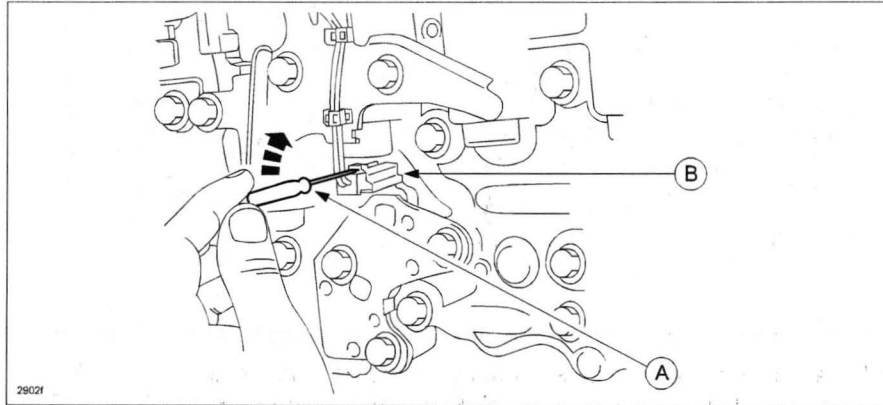
6. Remove oil pressure switch B.
 - a. Insert a precision flathead screwdriver (A) and move it in the direction of the arrow as shown to disconnect the oil pressure switch B connector.

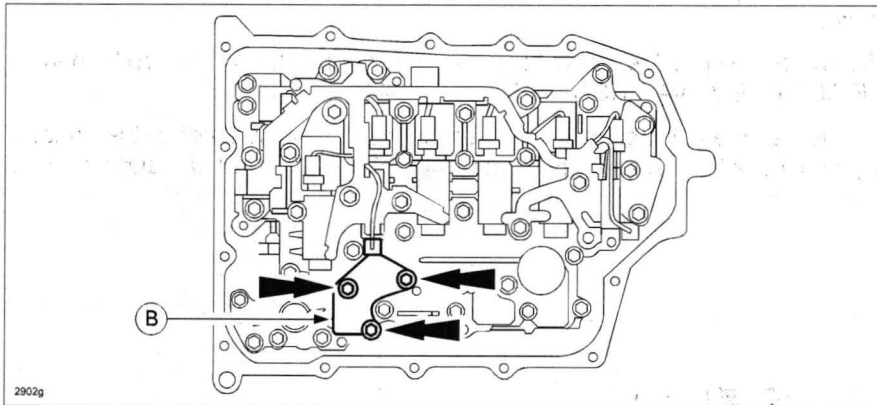
- b. Remove oil pressure switch B.

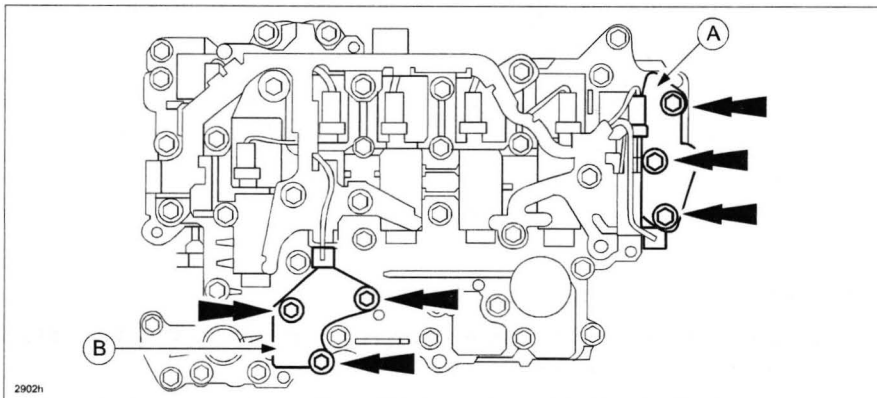
7. Install new oil pressure switches A and B.
8. Verify that the tab of each oil pressure switch A and B is attached correctly.
9. Install the bolts for oil pressure switches A and B.
Tightening torque: 9-10 N•m {92-101 khf•cm, 80-88 in•lbf}

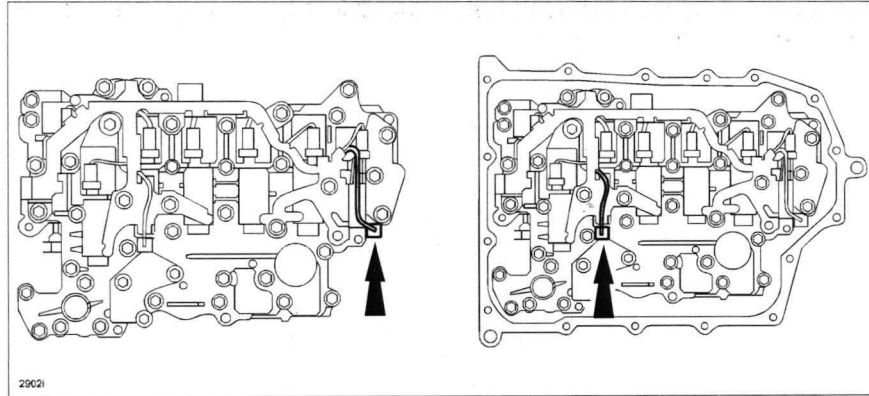
10. Connect the oil pressure switches A and B connectors.

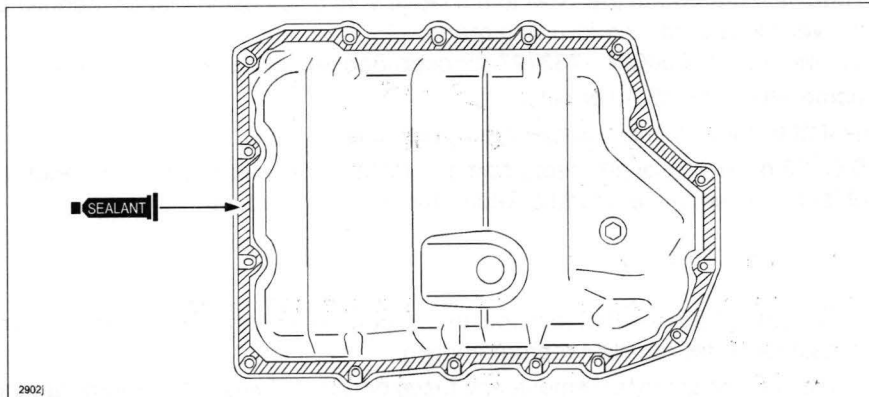
CAUTION: Clean any remaining silicone sealant off the contact surfaces of the transaxle case and oil pan.
a. Apply a light coat of silicon sealant to the contact surfaces of the oil pan and transaxle case.

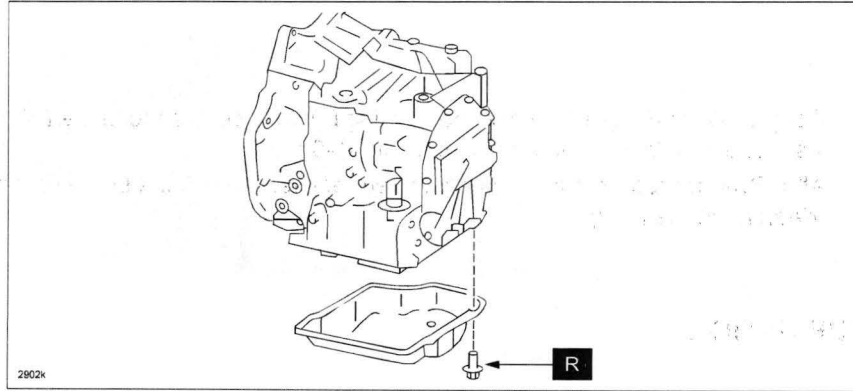
- b. Install the oil pan with new bolts before the applied sealant starts to harden.

Tightening torque: 8-10 N•m {82-101 khf•cm, 71-88 in•lbf}
