| RE: <b>Service Campaign 2014020003 - Rework Seam Seal at Spare Tire Well, MY 2014 C-Class (204)</b> | DATE: February 21, 2014 |

# Service Campaign Bulletin

Campaign No. 2014020003, February 2014

SUBJECT: **Model 204 (C-Class), Model Year 2014**  
**Rework Seam Seal at Spare Tire Well**

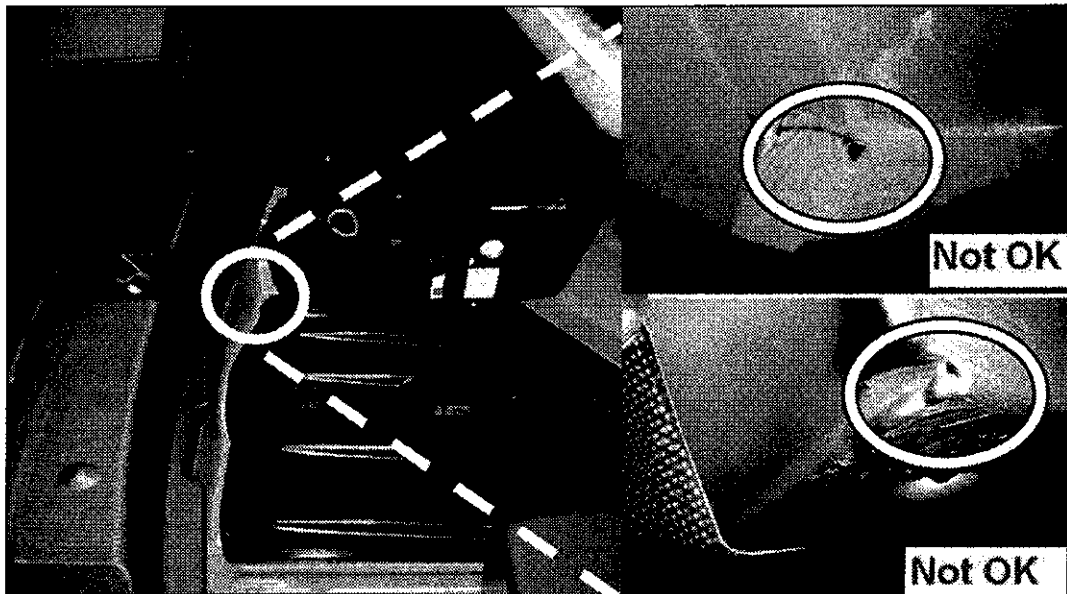
Figure 1

1. Check seal seam in area of spare tire well:
  - Check seal seam on marked corner area (Figure 1) inside of spare tire well.
  - Lift vehicle with vehicle lift.
  - Check seam seal on marked corner area (Figures 1, 3) outside of spare tire well.

- If seal seam is **not** damaged (both sides OK): **Procedure is complete.**
- If seal seam is damaged: **Proceed** to steps 2, 3.
