TO: Mercedes-Benz Dealer Principals, General Managers, Sales Managers, Service Managers, Parts Managers	FROM: Thomas Brunner, Department Manager, Vehicle Compliance and Analysis, Engineering Services
RE: Service Campaign 2014020004 - Check Weld Seams at Rear Axle Cross Member., MY 2014 E-Class (212), CLS (218)	DATE: March 14, 2014

Campaign No. 2014020004, March 2014

SUBJECT: **Models 212 (E-Class), 218 (CLS-Class), Model Year 2014**  
**Check Weld Seam at Rear Axle Cross Member at Left and Right, Rework if Necessary**

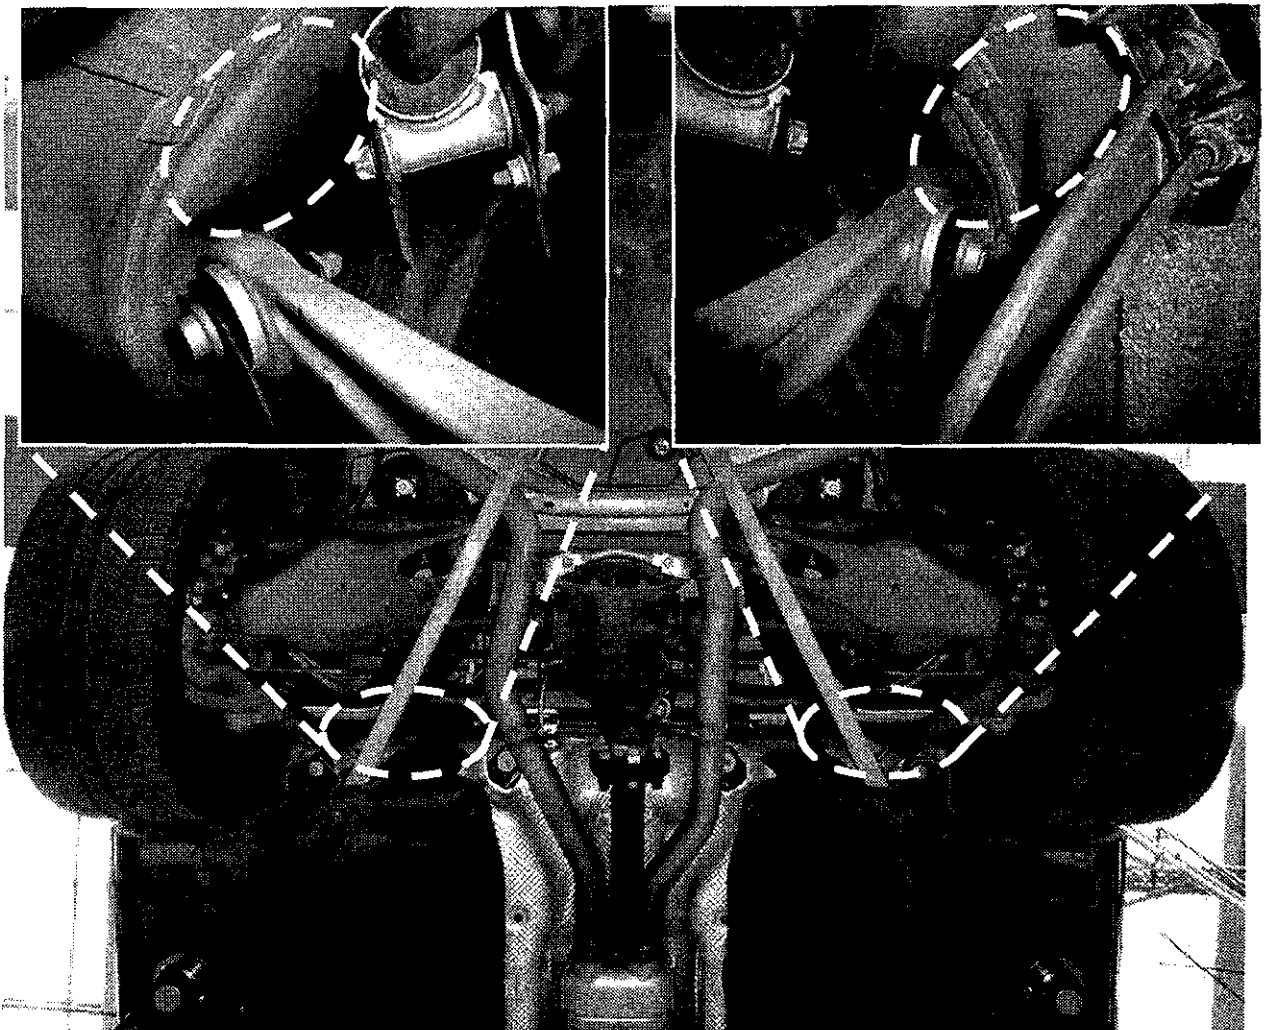
Figure 1

Check weld seam (in area circled, Figure 1) at right/left rear axle cross-member for crack using mirror:

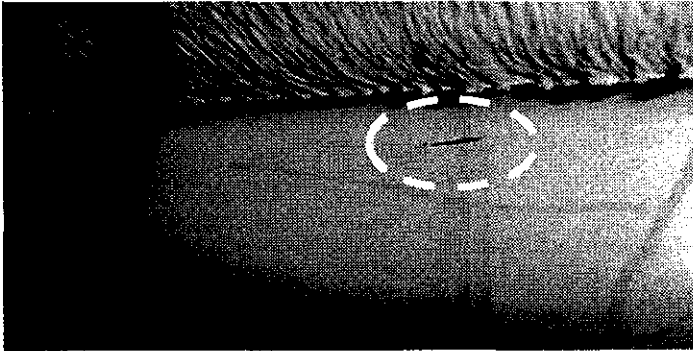
- If weld seam is OK: Procedure is complete.
- If weld seam is not OK (Figure 2): Proceed to Subject B.

Figure 2 not OK

Remove rear axle, refer to WIS: AR35.10-P-0010EW.

5. Prime and paint welded area with dull black aerosol paint.
6. Apply preservation agent to repaired area.
7. Reconnect negative battery cable, refer to WIS: AR54.10-P-0003EW
8.
