Mercedes-Benz

Campaign No. 2014070002, August 2014

SUBJECT: **Model 204.9, Model Year 2014**  
**Rework PVC Seam of A-pillar to Rocker Panel**

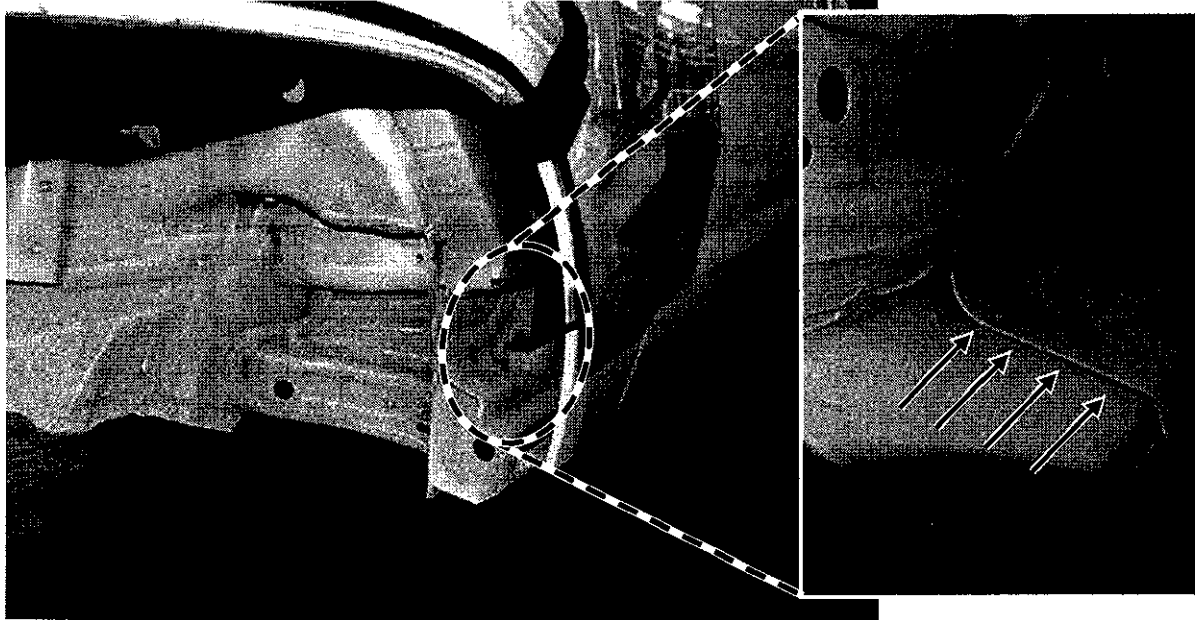
Figure 1

This Service Campaign has been initiated because Daimler AG (DAG), the manufacturer of Mercedes-Benz vehicles, has determined that a seam seal at the left A-pillar does not correspond to current production configuration. As a consequence, it is possible that water leaks may occur in this area. An authorized dealer will rework the seam seal at the left A-pillar at the next workshop visit.

Detach wheel arch liner on lower left front.
3. Seal exposed edge of A-pillar connection to rocker panel (arrows, Figure 1).

Be sure to clean affected area prior to applying seam sealant.
