HYUNDAI NEW THINKING. NEW POSSIBILITIES. Technical Service Bulletin	GROUP AUTOMATIC TRANSMISSION	NUMBER 14-AT-007
	DATE MAY 2014	MODEL Genesis Sedan (BH/DH) Genesis Coupe (BK) Equus (VI)
SUBJECT:	AUTOMATIC TRANSMISSION (8-SPEED) INHIBITOR SWITCH DTC P0705 & P0706

This TSB supersedes TSB 13-AT-015 to add the 2015 Genesis (DH)

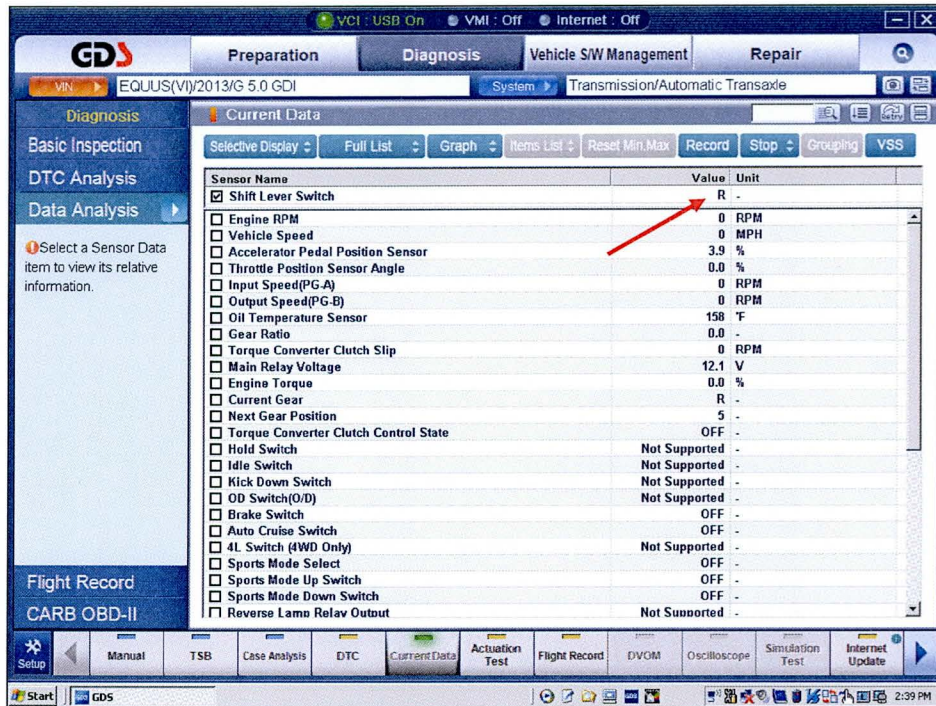
1. Push the Start/Stop Button two times without depressing the brake pedal.
2. Attach a GDS and check for DTC in the “Automatic Transaxle” menu. **Record the DTC and description.** Delete the DTC.
3. Select the following parameters. Move the shift lever through all gears and confirm the GDS shows P, R, N and D.
 - Vehicle and A/T menu.
 - “Current Data”
 - Shift Lever Switch.

4. If the Shift Lever Switch shows:
 - The correct shift lever position (P, R, N and D), the wiring **currently** has no open/short circuits. Go to Step 6.
 - Does not show the correct shift lever position, go to Step 5.
5. Visually check the wiring harness between the TCM and inhibitor switch for any damaged wires or open circuit/short circuit to ground. Check for any damaged pins or pins not fully inserted into the connector.
 - If damage exists, repair or replace the control wiring and drive the vehicle to confirm the repair.
 - If no damage or open/short circuit is found, go to Step 6.
