HYUNDAI NEW THINKING. NEW POSSIBILITIES. Technical Service Bulletin	GROUP AUTOMATIC TRANSMISSION	NUMBER 14-AT-015
	DATE NOVEMBER 2014	MODEL 2013~ Santa Fe (NC) AWD
SUBJECT:	AUTOMATIC TRANSAXLE NOISE FROM TRANSMISSION AT SLOW SPEEDS

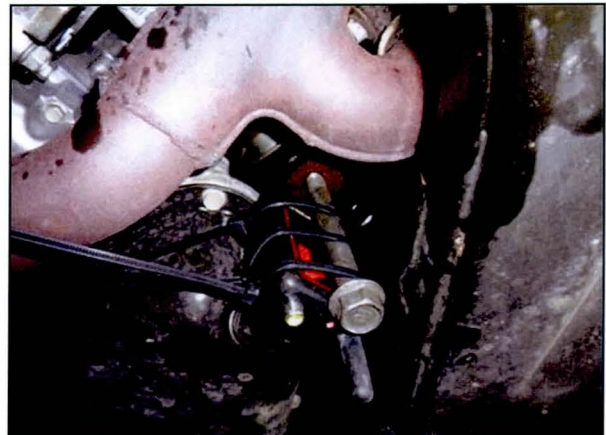
In this illustration, a bolt was threaded into the transmission support housing and the Wireless Chassis Ear was secured to the bolt.

2. Accelerate the vehicle from a stop at slow speeds and listen for noise from the bellhousing area. If a buzzing or scraping noise is heard, go to Step 3 and replace the crankshaft position sensor wheel and plate.
3. Refer to the Santa Fe Shop Manual and remove the transmission.
4. Remove the crankshaft position sensor wheel and plate and replace with a new part.

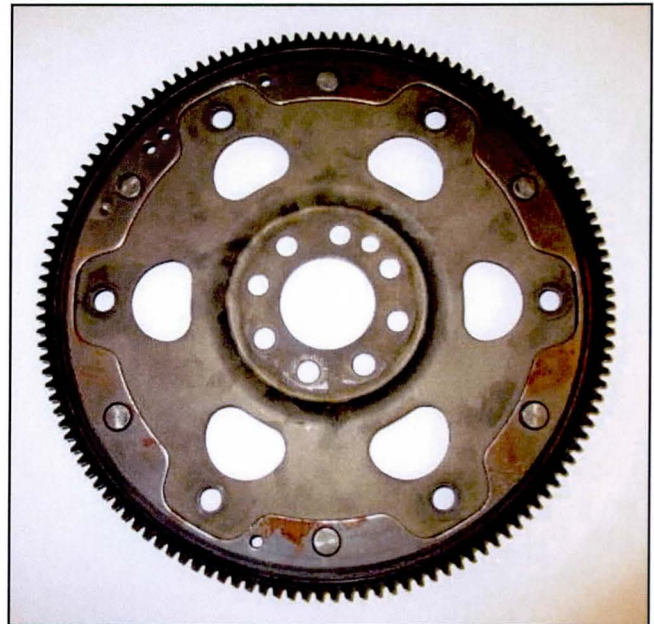
Description: Some Santa Fe (NC) AWD vehicles may experience a buzzing or scraping noise from the area of the transmission when accelerating at slow speeds. The noise may be caused by the crank position sensor wheel and the starter ring gear flexing/vibrating during acceleration or slow speed driving.

Install 8 bolts and torque to specification.

Torque: 53~56 lb-ft (7~8 kgf.m, 72~75 N.m)
