SERVICE BULLETIN RELEASE - 03/25/2014

05-005/14 – MULTI-MODEL (WITH SKYACTIV 6AT) - CHECK ENGINE LIGHT AND AUTOMATIC TRANSAXLE WARNING LIGHT ON WITH DTC P0842, P0847, P0872 AND/OR P0877 STORED IN TCM MEMORY

Subject: CHECK ENGINE LIGHT AND AUTOMATIC TRANSAXLE WARNING LIGHT ON WITH DTC P0842, P0847, P0872 AND/OR P0877 STORED IN TCM MEMORY	Bulletin No: 05-005/14
	Last Issued: 03/25/2014

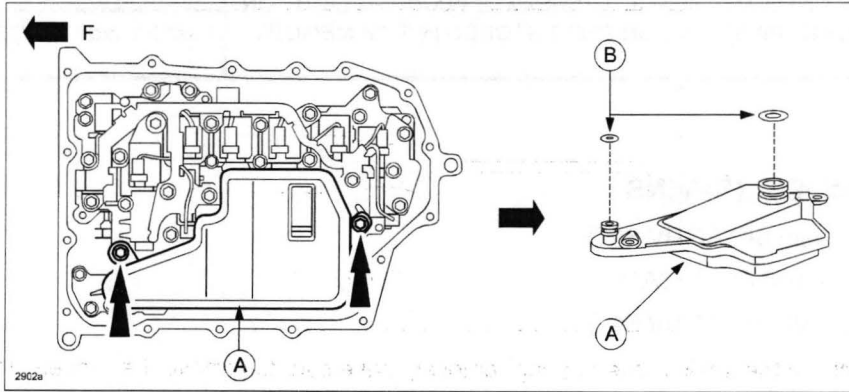
4. Remove the oil strainer (A) and the oil strainer O-rings (B) from the transaxle.
F=Front of vehicle

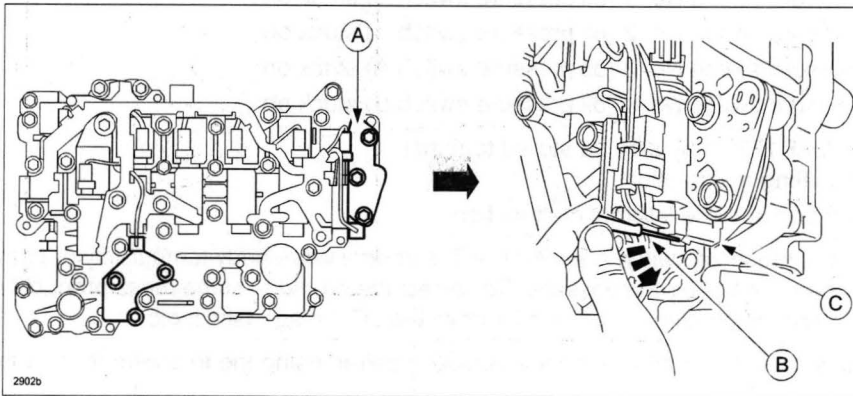
5. Remove oil pressure switch A.
a. At oil pressure switch A, insert a precision flathead screwdriver (B) and move it in the direction of the arrow in the figure to disconnect the oil pressure switch A connector (C).

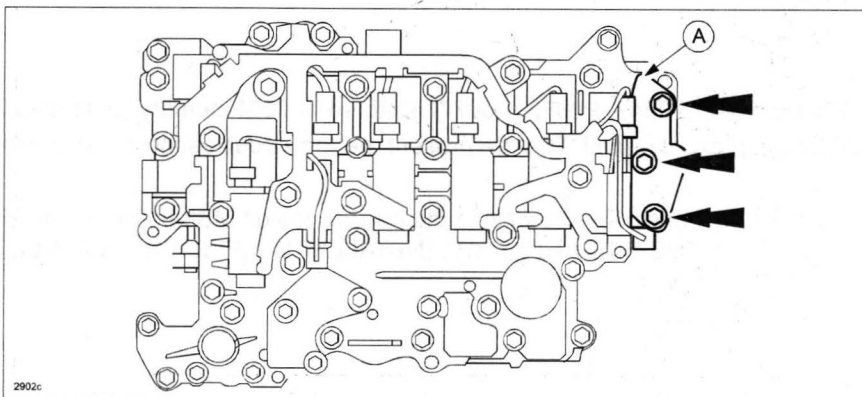
- b. Remove the bolts for oil pressure switch A.

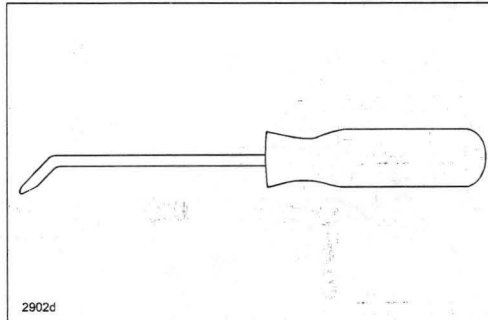
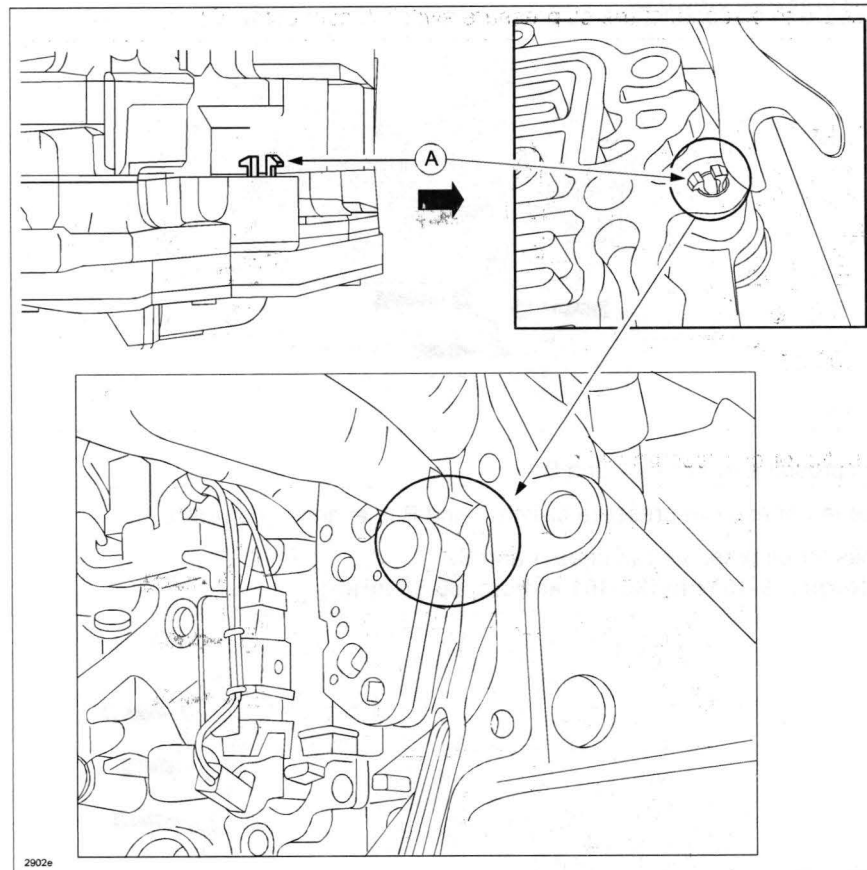
- c. Detach the tab shown and remove oil pressure switch A from the control valve body.
1. Using an appropriate tool (such as a fastener remover), push the tab (A) of oil pressure switch A.

CAUTION: If the tab is broken during removal, make sure to remove the broken pieces.

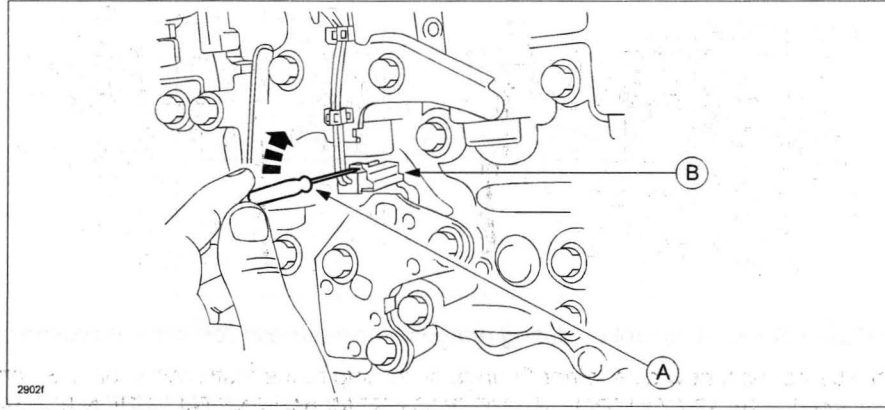
6. Remove oil pressure switch B.
 - a. Insert a precision flathead screwdriver (A) and move it in the direction of the arrow as shown to disconnect the oil pressure switch B connector.

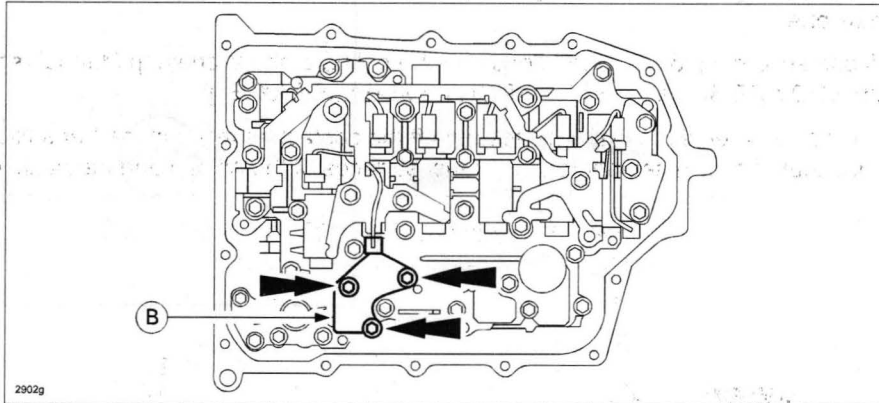
- b. Remove oil pressure switch B.

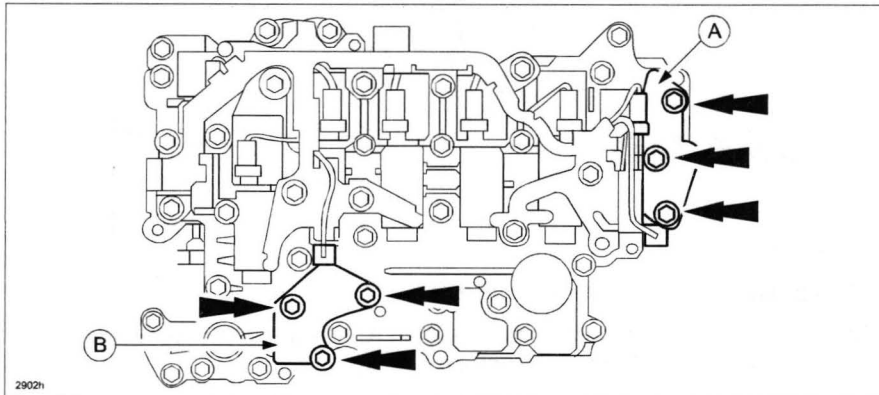
7. Install new oil pressure switches A and B.
8. Verify that the tab of each oil pressure switch A and B is attached correctly.
9. Install the bolts for oil pressure switches A and B.
Tightening torque: 9-10 N•m {92-101 khf•cm, 80-88 in•lbf}

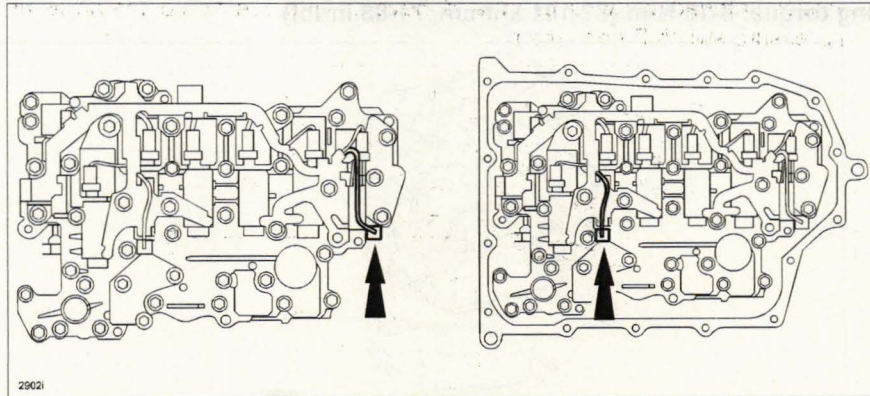
10. Connect the oil pressure switches A and B connectors.

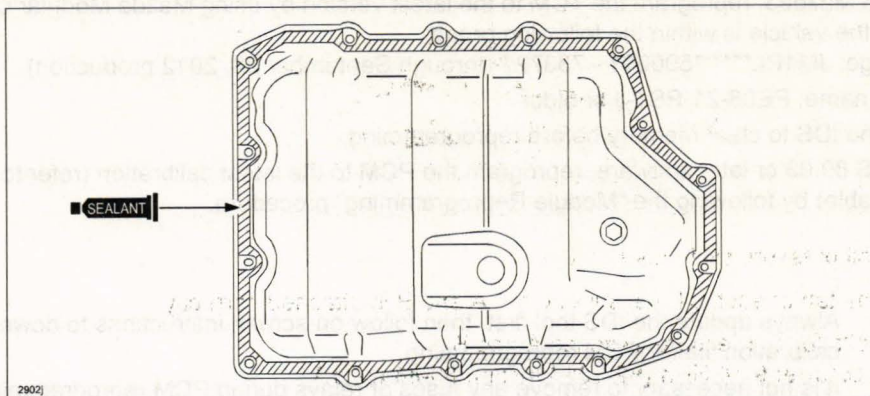
CAUTION: Clean any remaining silicone sealant off the contact surfaces of the transaxle case and oil pan.
a. Apply a light coat of silicon sealant to the contact surfaces of the oil pan and transaxle case.

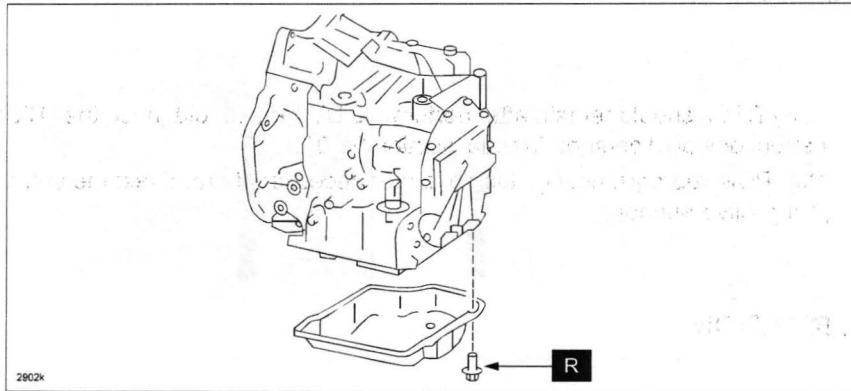
- b. Install the oil pan with new bolts before the applied sealant starts to harden.

Tightening torque: 8-10 N•m {82-101 khf•cm, 71-88 in•lbf}
