SERVICE BULLETIN RELEASE - 07/14/2014

05-008/14 – MULTI-MODEL (6 SPEED SKYACTIV M/T) - HARD TO SHIFT INTO 3RD GEAR

Subject: HARD TO SHIFT INTO 3RD GEAR	Bulletin No: 05-008/14
	Last Issued: 07/14/2014

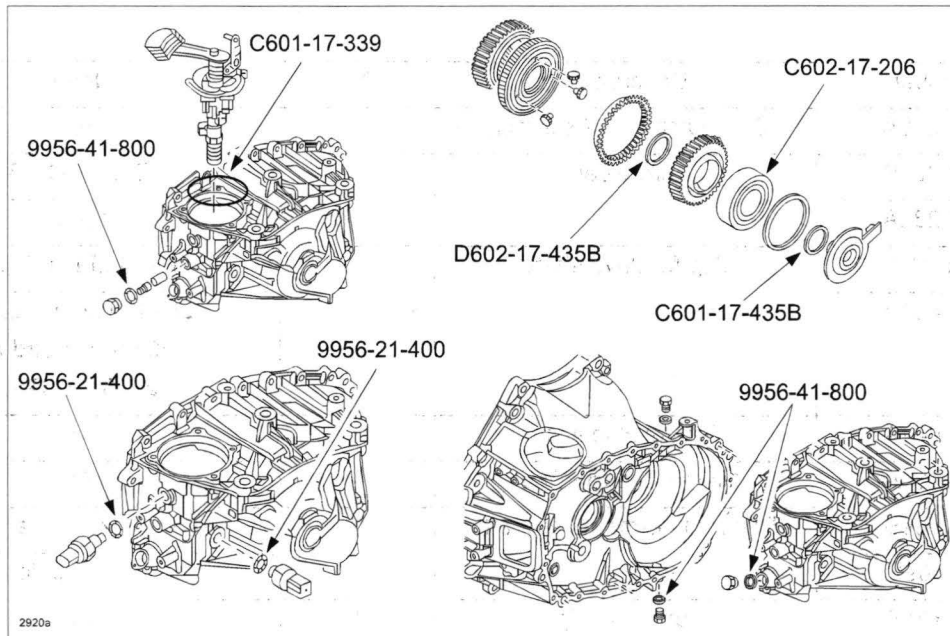
This is caused by the friction coefficient between the 3/4 clutch hub and the sleeve increasing. A surface treatment has now been added to the 3/4 clutch hub to decrease the friction coefficient.

1. Verify customer concern.
2. Remove the transaxle. Refer to MS3 online instructions or the Workshop Manual section 05-15.
3. Replace the 3/4 clutch hub with a modified one and the 3rd gear with a new one (listed in the Parts Information). Refer to the C66M-R 6-speed SKYACTIV Manual Transaxle Workshop Manual.
