**05-009/14 - 2014 MAZDA6 - A/T SHIFT LEVER IS HARD TO MOVE**

<b>Subject:</b>  A/T SHIFT LEVER IS HARD TO MOVE	<b>Bulletin No:</b> 05-009/14
	<b>Last Issued:</b> 08/29/2014

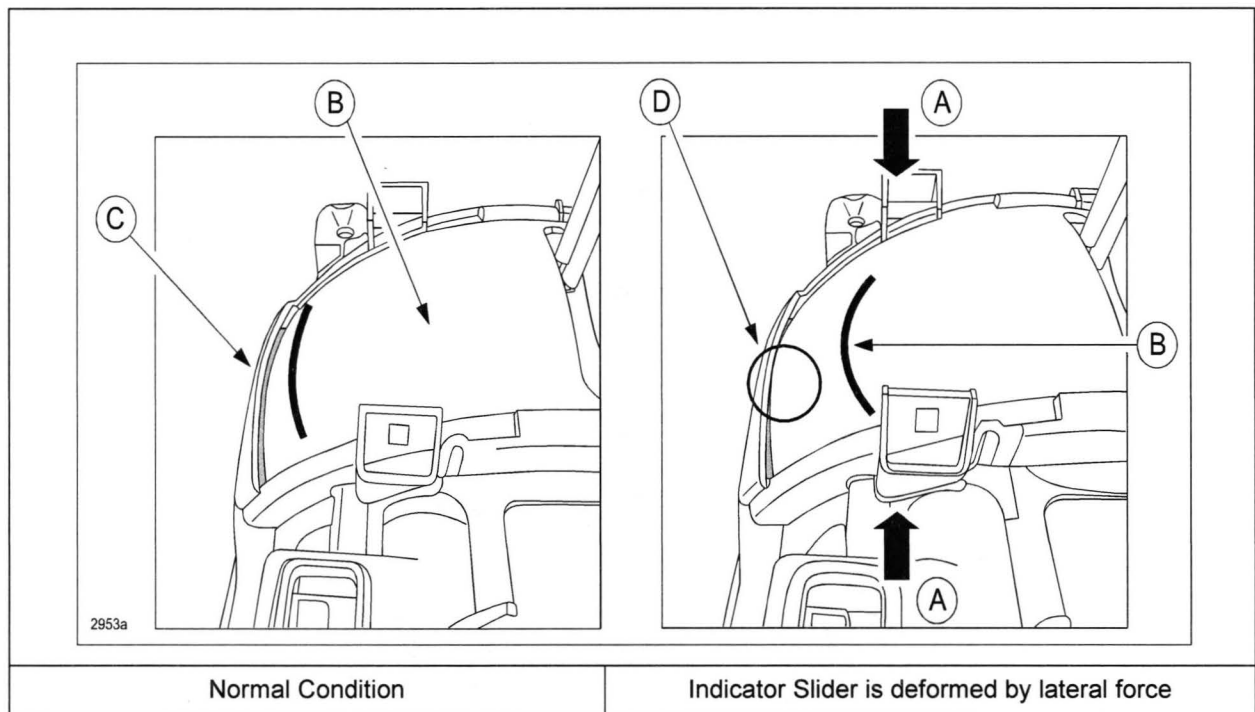
Some customers may find it difficult or hard to move the A/T shift lever.

When the driver or front passenger's leg contacts the center console, lateral force (A) may deform the indicator slider (B), causing the slider edge to contact the arched part of the set plate (D). This may cause damage to the indicator slider (B) and/or hard A/T shift lever movement.

Customers having this concern should have their vehicle repaired using the following repair procedure.
