**SERVICE BULLETIN RELEASE - 07/29/2014**

**06-002/14 - MULTI-MODEL - UNUSUAL NOISE WHEN STARTING TO MOVE VEHICLE WHILE STEERING WHEEL IS TURNED TO FULL LEFT POSITION**

<b>Subject:</b> UNUSUAL NOISE WHEN STARTING TO MOVE VEHICLE WHILE STEERING WHEEL IS TURNED TO FULL LEFT POSITION	<b>Bulletin No:</b> 06-002/14
	<b>Last Issued:</b> 07/29/2014

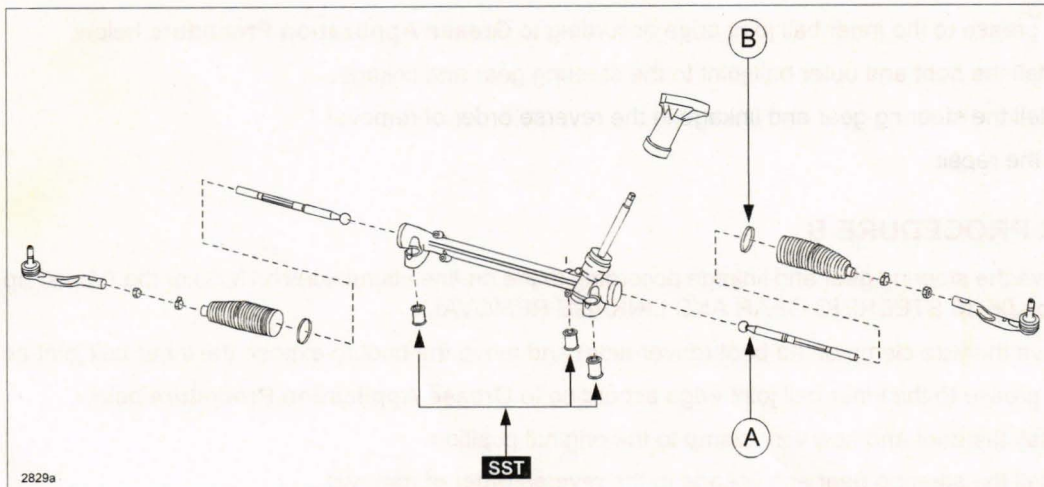
Some vehicles may exhibit an unusual (clacking) noise from under the front of the vehicle. This noise only occurs when starting to move the vehicle while the steering wheel is turned to the full left position.

The noise is caused when the edge of the left side inner ball joint (A) gets stuck with the steering gear housing.

The following modifications have been made to eliminate the noise:

1. The shape of the inner ball joint edge has been changed.
2. Grease has been applied to the inner ball joint edge.
