### **SERVICE BULLETIN RELEASE - 07/08/2014**

<b>Subject:</b> A/C MODE SELECTOR DIAL DOES NOT STAY IN "DEFROSTER VENTS" POSITION - (MANUAL A/C ONLY)	<b>Bulletin No:</b> 07-001/14
	<b>Last Issued:</b> 07/08/2014

2013-2015 CX-5 vehicles equipped with manual type air conditioning system with VINs lower than JM3KE\*\*\*\*\*488298 (produced before June 1, 2014)

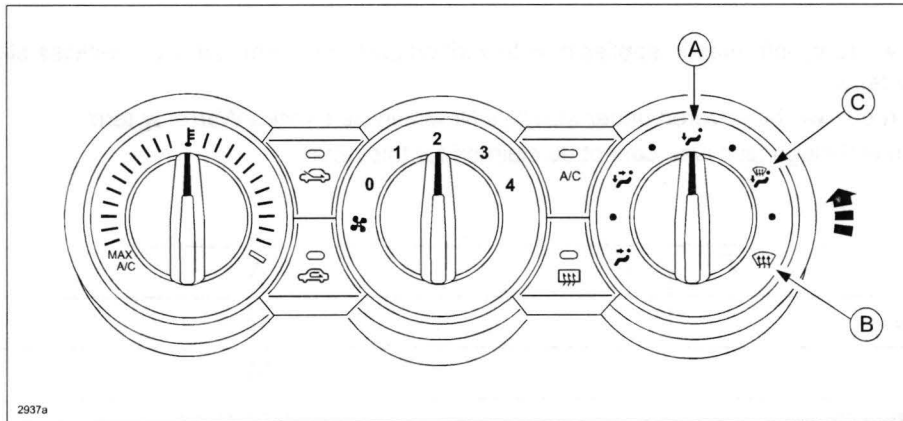
When selecting the "Defroster Vents" position (B) with the Mode Selector Dial (A), some customers may notice the dial does not stay in the "Defroster Vents" position and returns to the "Defroster/Floor Vents" position (C).

1. Replace the mode control wire with a modified one according to the instructions on MS3 online or the Workshop Manual (section 07-40 CLIMATE CONTROL UNIT REMOVAL/INSTALLATION [MANUAL AIR CONDITIONER])
2. Verify the repair.

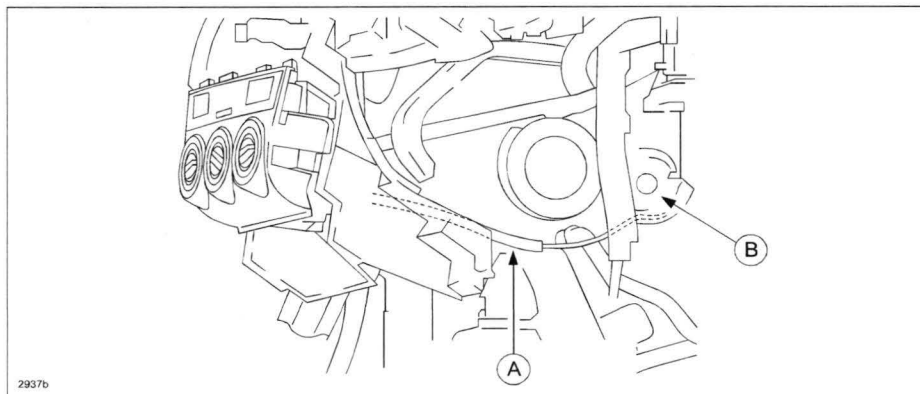
This concern may be due to a production variation. Some of the mode control wires (A) may be too long to transmit movement from the mode selector dial to the link (B). The length of the mode control wire has been shortened to eliminate this concern.

Part Number	Description	Qty.	Notes
KD45-61-C35A	Mode Control Wire	1	Manual A/C System
