09-001/14 – 2014 MAZDA3 - RATTLE, SNAP, POP OR CRACK NOISE FROM BOTTOM OF A-PILLAR

<b>Subject:</b> RATTLE, SNAP, POP OR CRACK NOISE FROM BOTTOM OF A-PILLAR	<b>Bulletin No:</b> 09-001/14
	<b>Last Issued:</b> 08/01/2014

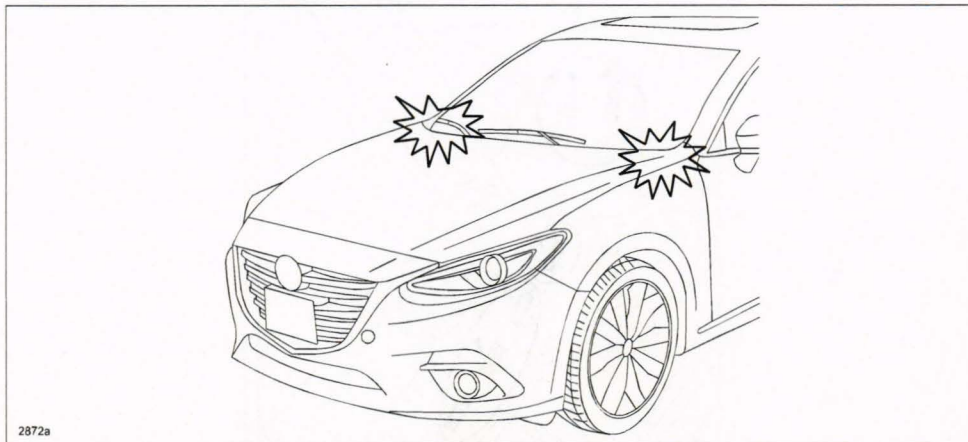
Some vehicles may exhibit a noise from the bottom of the A-pillar when driving on rough roads or over bumps. This is caused by the cowl upper plate and/or dash upper panel interfering with the wiper bracket. For the affected vehicles, a clearance needs to be created between the wiper bracket and cowl upper plate and between the wiper bracket and dash upper panel.

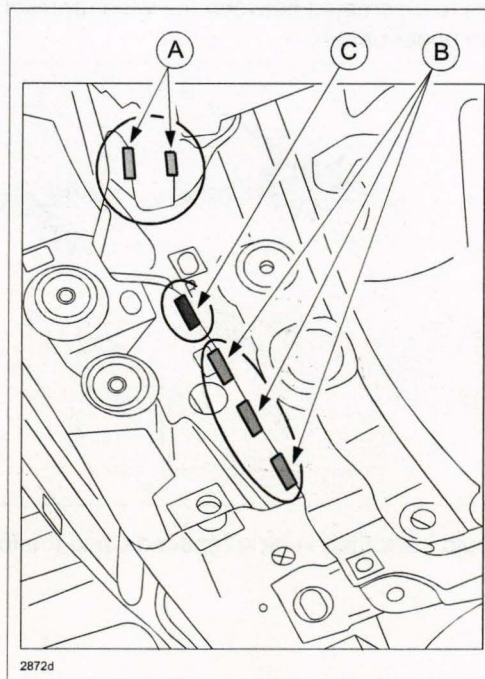
**Area A for all vehicles**

Locations to create clearance

- Areas A and B: Create a clearance for all vehicles
- Area C: Create a clearance for vehicles with VIN range JM1BM\*\*\*\*\*100001 - 189735

- Place the tip of a covered\* flat-blade screwdriver (A) between the wiper bracket (B) and the dash upper panel/cowl upper plate (C) and hit the head of the screwdriver with a hammer to create a clearance of approximately 0.5 mm (D) between the two.
