# Service Bulletin

| <b>Subject:</b><br><br>RATTLE NOISE FROM BOTTOM OF A-PILLAR | <b>Bulletin No:</b> 09-001/14 |

2014 Mazda3 with VINS lower than JM1BM\*\*\*\*\*154277 (produced before December 1, 2013)

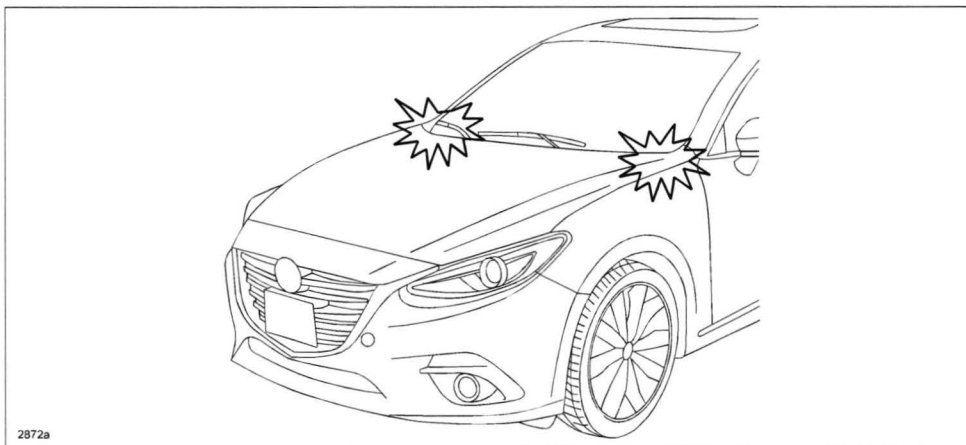
Some vehicles may exhibit a rattle noise from the bottom of the A-pillar when driving on rough roads or over bumps. This is caused by the cowl upper plate and/or dash upper panel interfering with the wiper bracket. To correct the problem, the shape of the wiper bracket has been changed. For the affected vehicles, a clearance needs to be created between the wiper bracket and cowl upper plate and between the wiper bracket and dash upper panel.
