# Service Bulletin

| <b>Subject:</b><br><br>RATTLE NOISE FROM BOTTOM OF A-PILLAR | <b>Bulletin No:</b> 09-001/14 |
| | <b>Last Issued:</b> 03/28/2014 |

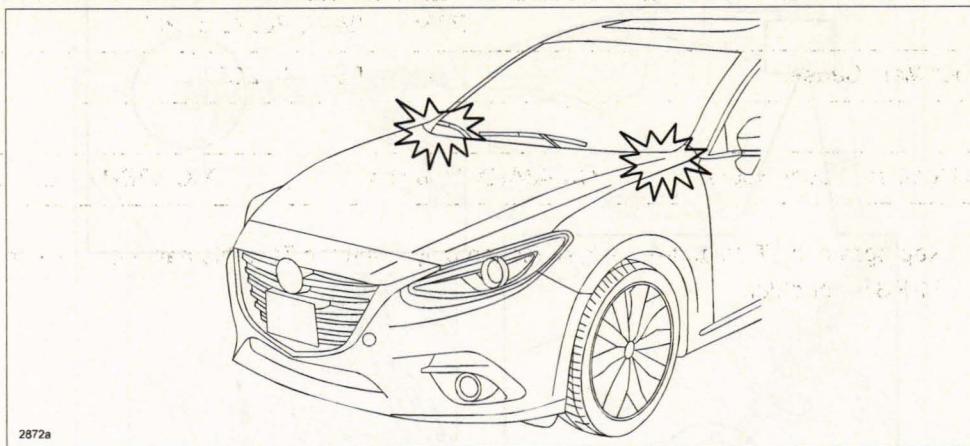
Some vehicles may exhibit a rattle noise from the bottom of the A-pillar when driving on rough roads or over bumps. This is caused by the cowl upper plate and/or dash upper panel interfering with the wiper bracket. To correct the problem, spot welding locations to the dash and cowl assembly have been changed. For the affected vehicles, a clearance needs to be created between the wiper bracket and cowl upper plate and between the wiper bracket and dash upper panel.

Customers having this concern should have their vehicle repaired using the following repair procedure.
