Mercedes-Benz

Customer ONE Action

Date: November 2014
Action No.: C1A141101
Group: 07

SUBJECT: **Model 156 (GLA)
Model Year 2015
Update Injector Coding**

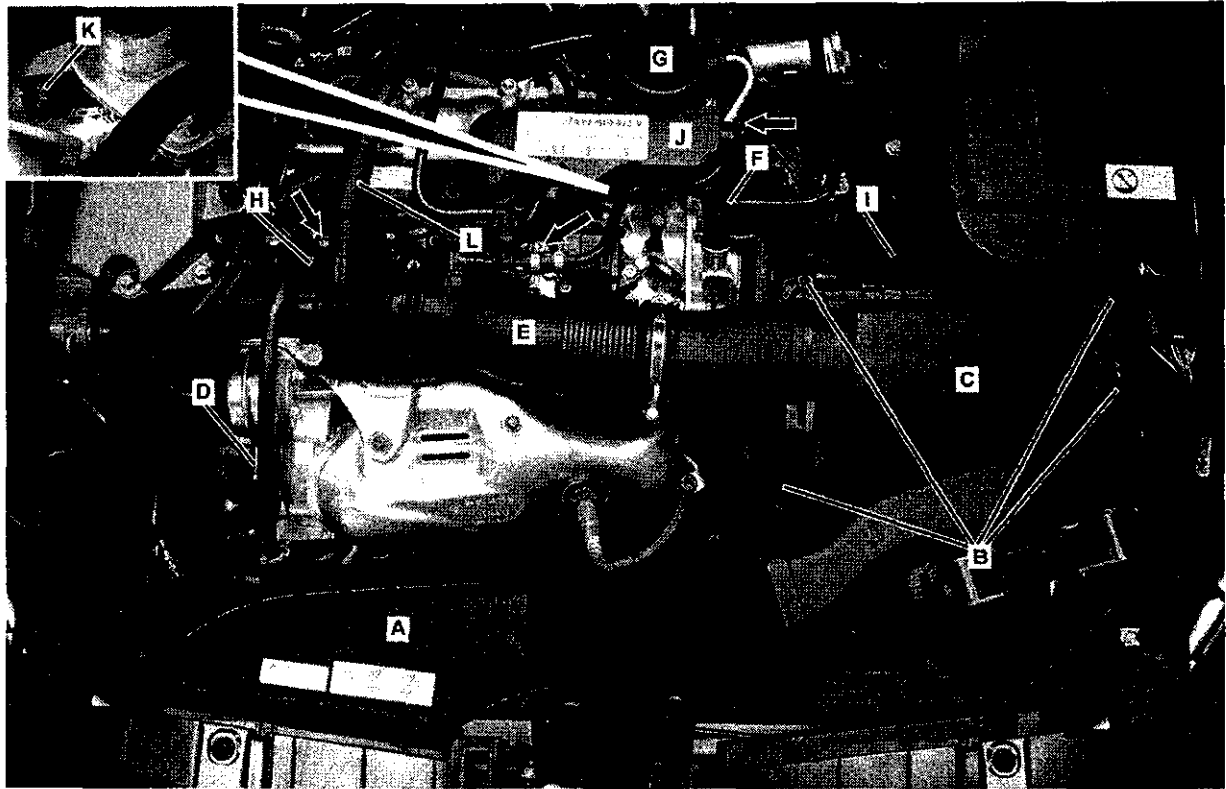
Figure 1

This Customer One Action has been initiated because the injector coding may not meet current specifications in the subject vehicles.
Dealers will update injector injection quantity adjustment to correct this condition prior to retail.

2. Disconnect injector harness cover (J, Figure 1) from engine:
 - Disconnect air intake duct (A) from radiator cross member
 - Remove 4 screws (B) from air cleaner cover (C).
 - Loosen hose clamp (D) on charge air intake duct (E).
 - Unclip brake booster line (F) from engine and move to one side.
 - Remove cover (G) over high pressure fuel pump.
 - Unclip engine harness (H) from intake duct.
 - Unclip engine harness (I) from air cleaner.
 - Remove 3 torx bolts (arrows) to loosen engine harness from engine.
 - Lift up engine harness cover (J) slightly then unclip injector harnesses from injectors.

Do not disconnect vent line (L) from charge air intake duct (E) or damage may occur.

- Injector code (K, Figure 1) can be read after disconnecting engine harness connector from injector. Refer also to Figure 2.
- If injector code (K, Figure 1) found on each injector, is **different** from injector code indicated on Star Diagnosis screen, proceed with injector coding (follow-on screen instructions). If injector code (K, Figure 1) found on each injector is the **same** as injector code on Star Diagnosis screen, injector coding is **not** required.
