MODEL  
2015MY  
Sedona (YP)  
(L, LX Only)

NUMBER  
073 (REV 1, 11/26/2014)

## TECHNICAL SERVICE BULLETIN

SERVICE ACTION: INSTRUMENT CLUSTER  
LOGIC IMPROVEMENT (SA176)

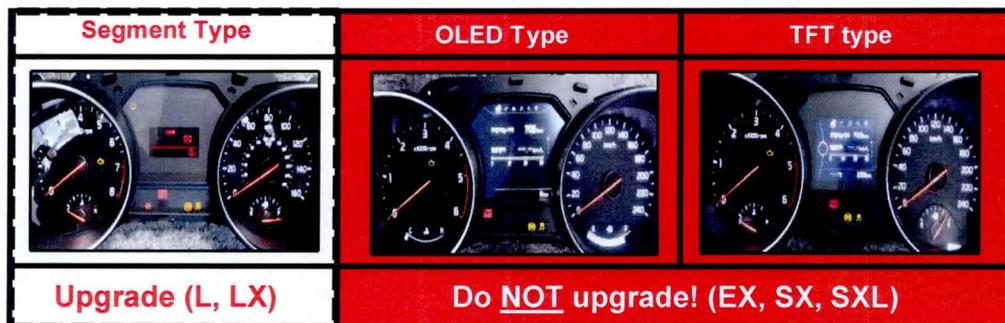
This bulletin provides information related to a software upgrade for the Instrument Cluster (see affected cluster type below) of some 2015MY Sedona (YP) vehicles (L and LX trim levels), produced from August 11, 2014 through November 8, 2014, which may exhibit a parasitic draw of up to 200-250 milliamps (mA), when the main fuse box switch is set to "ON", in key OFF/doors locked condition. As a result, the electronic modules may not enter "sleep" mode and cause the battery to be drained, after a few days. To prevent and/or correct this condition, the instrument cluster should be reprogrammed using the GDS download, as described in this bulletin. Kia is requesting the completion of this Service Action on all affected vehicles, including dealer stock, prior to delivery. For confirmation that the latest reflash has been done to a vehicle you are working on, verify ROM ID using the tables in this TSB.

The Segment Type cluster has a black background with red LED lettering.

To correct this condition, the Instrument Cluster should be reprogrammed using the GDS download as described in this bulletin.
