GROUP BOD	MODEL 2012-13MY Optima (QF)
	NUMBER 104	DATE May 2014
TECHNICAL SERVICE BULLETIN		
SUBJECT: DRIVER'S SIDE SEAT CUSHION COVER DETACHING

This bulletin provides information about some 2012~2013MY Optima (QF) models, produced from August 9, 2011 through April 11, 2013, which may experience a loose or disengaged driver's side seat outer trim cover. Follow the procedure outlined in this TSB to correct the concern.

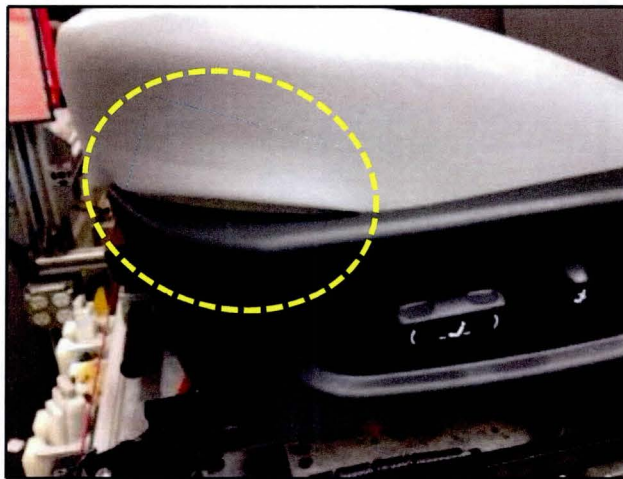
Seat Cover Detached
