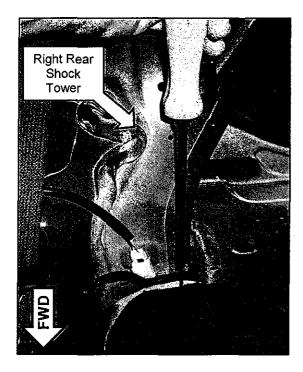
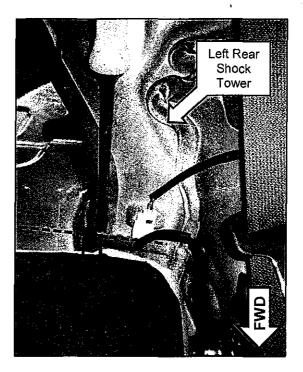
When addressing a customer complaint related to a squeaking sound emanating from the rear of the vehicle, and the noise can be isolated to the rear suspension, check the right and left rear shock towers as the most likely source of the noise. Once the noise has been isolated to either shock tower, use a large flat-head screw driver to provide extra clearance between the metal surfaces, at the locations shown in the images below. Make sure to only provide enough clearance to alleviate the noise concern. A sound file is available for reference by clicking on the attachment above.
