GROUP Body	MODEL 2006-2014MY Sedona (VQ)
	NUMBER PS306	DATE June 2014

SUBJECT: SECOND ROW SEAT RELEASE MECHANISM INOPERATIVE

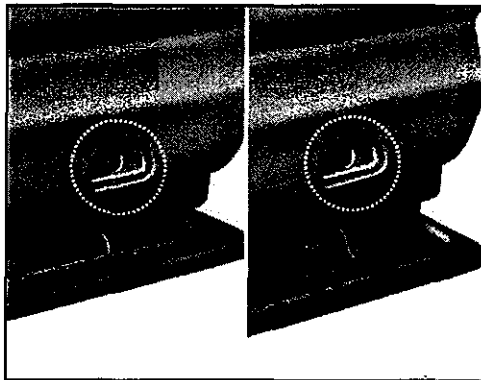
- Latch lock indicator shows a green circle on both sides of the seat base. If not, make sure the seat is properly installed.

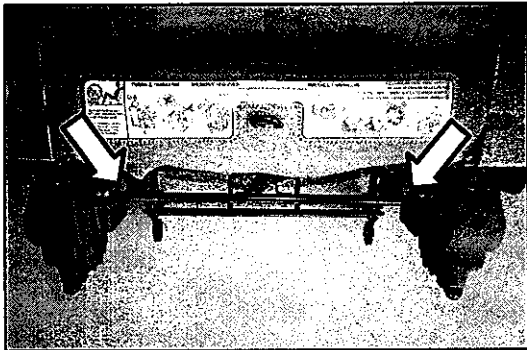
1. Move the seat to the full forward position and locate the seat release cables on the left and right side of the seat track.

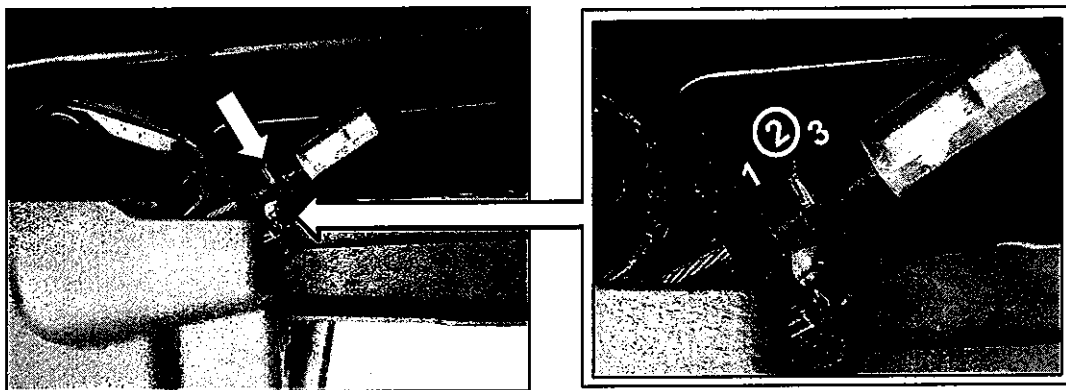
2. Check the current position for the seat release cable adjuster. The default setting from the factory is in slot two (2).

3. If more tension is required to operate the release mechanism, remove the cable adjuster from the default slot and place it in slot one (1).
4. If there is excess cable tension in the mechanism, remove the cable adjuster from the default slot and place it in slot three (3).
5. Operate the seat release handle to make sure the seat will tumble forward.
6. Repeat the steps above on the opposite side second row seat, if necessary.
