GROUP  
Chassis

MODEL  
2014MY  
Sorento (XMa)

NUMBER  
PS323

SUBJECT: INTERMITTENT POPPING NOISE FROM REAR OVER BUMPS

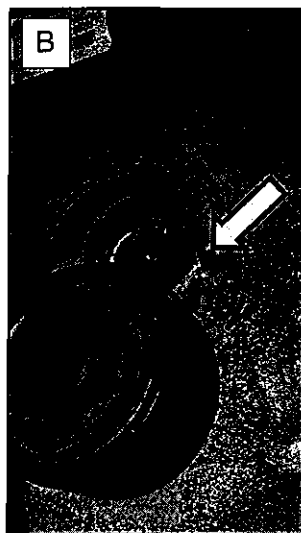
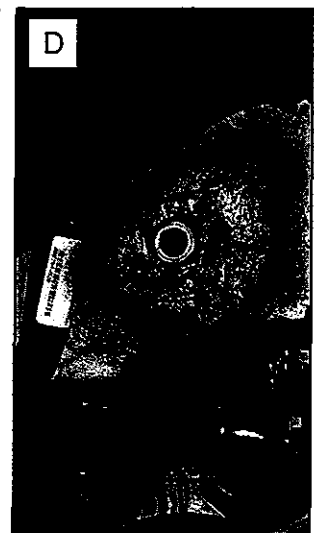
On some 2014MY Sorento (XMa) vehicles, built before September 26, 2013, a customer may complain of a very intermittent light knock, or popping noise, heard from the rear of the vehicle over rough road surfaces. This condition is caused by an excessive amount of weld bead applied around the rear shock upper mount which prevents the shock from being seated squarely against the vehicle body mount and may cause damage to the mounting flange on the shock absorber (A).

To correct this concern, remove the shock absorber and inspect for an excess amount of weld bead around the upper rear shock absorber vehicle mounts (B). If excess weld bead is present, use a die grinder, or small abrasive disk, to remove the excess material until the shock will sit flush against the mounting surface (C). After all excess material has been removed, spray any exposed surfaces with rubberized undercoating (D). If the original shock is damaged, install a new shock absorber and submit a warranty claim using the op code in the LTS. Finally, test drive the vehicle to confirm the repair.
