GROUP Service Campaign	MODEL 2015 MY Sedona (YP) (EX, SX & SXL)
	NUMBER SC109 (REV 1, 12/19/2014)	DATE December 2014
VOLUNTARY SERVICE CAMPAIGN		
SUBJECT: SEDONA (YP) – <u>BCM</u> LOGIC REPROGRAMMING (SC109)

SUBJECT: SEDONA (YP) – BCM LOGIC REPROGRAMMING (SC109)

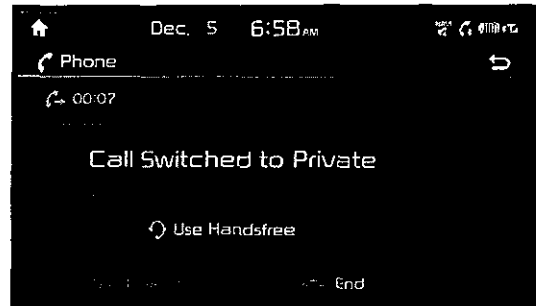
This article provides information related to possible Bluetooth concerns when using an iPhone® with iOS 8.X (iOS 8, 8.0.1, 8.0.2, 8.1, 8.1.2, etc.) while paired to a head unit. The concerns include:

- Phone fails to transfer to hands-free (stays in Private Mode) or sometimes can be transferred to head unit when hands-free button is selected
- Calls cannot be initiated using Bluetooth
- Audio streaming is inoperative
- Unable to use head unit/steering wheel controls when using iPhone in iPod® mode
- Bluetooth streaming volume too low
- Phone call and music streaming at the same time
- Other Bluetooth related concerns (difficulties during initial pairing, etc.)

The following suggestions may improve any Bluetooth related concerns:

- Customers should continue to update to the latest version of the iOS 8 operating system for possible Bluetooth improvements rolled out by Apple®
- Reboot the customer's phone (turn the phone off and back on). This will resolve many of the concerns for a period of time. Although, some concerns may re-occur over time.
- Delete the phone from the head unit and the head unit from the phone. Then, perform a new pairing of the phone and the head unit.
